AN EXCHANGE OF TECHNICAL INFORMATION

Number: TL011 - 2022
Subject: NaturaLINE Compressor Icing

Released: December 09, 2022

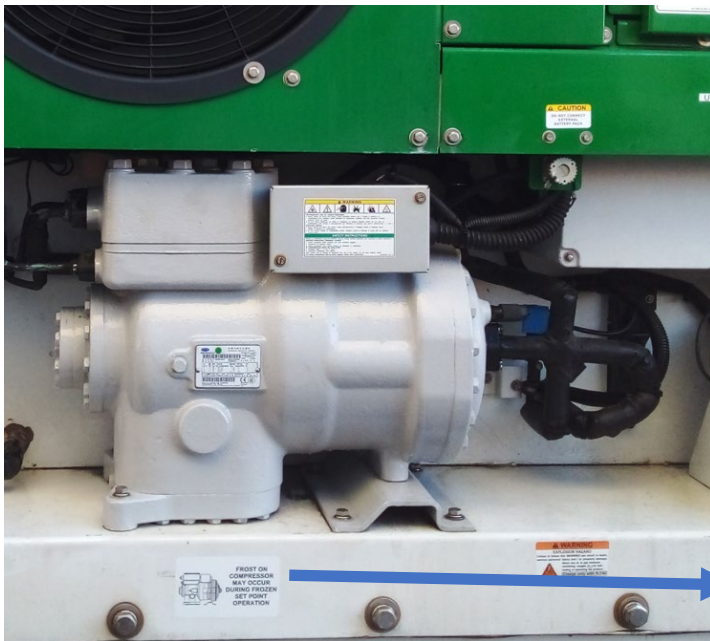
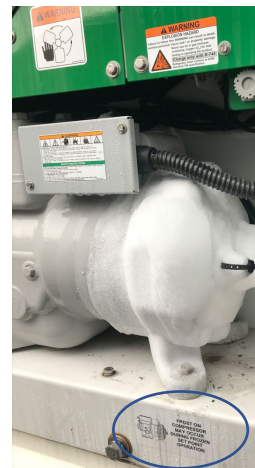
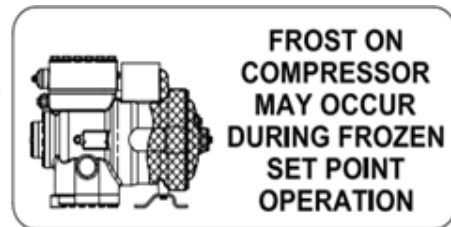
CTD PART NO.: 62-66170-00

Compressor icing can occur on the suction line and the compressor end bell when running at low cargo setpoints at lower ambient and higher humidity conditions. This operation is normal and will not affect the reliability of the unit. For awareness, we have placed a label on the front of the unit. If your unit does not have the label, contact your Carrier Field Engineering Manager and one will be provided.
