AN EXCHANGE OF TECHNICAL INFORMATION

Number: TL004 - 2026

Subject: LYNX™ Fleet / Telematics Communication Reset

Released: May 5, 2026

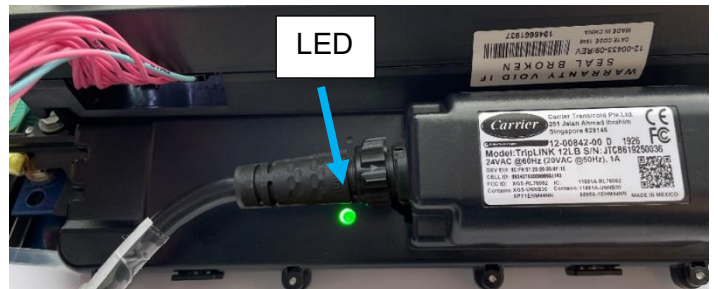
If the LED is a solid green and not reporting to the LYNX portal within 30 minutes, the Telematics device may have the storage management concern.

If the issue is identified, please leave the reefer powered on and contact the Carrier LYNX support team (container.support@carrier.com) with the details of the reefer affected. They will take the necessary actions to remotely perform a factory reset of the module for its continued use. The support team will contact you once the issue is resolved.
