AN EXCHANGE OF TECHNICAL INFORMATION

**Number:** TL007 - 2025  
**Subject:** USB Detection

**Released:** November 5, 2025

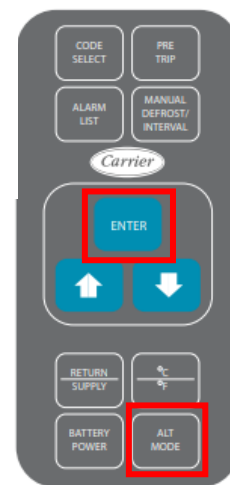
Carrier has received reports of a “no USB” message being displayed primarily on OptimaLINE units. On testing, it was found that the logic to detect USBs was ending too quickly and some USBs would not be detected in time. If this occurs, follow the listed procedure prior to determining the USB is bad.

1. Insert the USB into the ML5 controller.
2. If the unit is off, power on the ML5 unit and wait for the startup sequence to complete and the setpoint to be displayed.
3. Press the ALT MODE key on the keypad.
4. Use the Arrow keys until “USb” is displayed, then press the ENTER key.
5. If “No USb” appears on the screen, press the ALT MODE key and then the ENTER key two times in quick succession. NOTE: if too much time is taken to press the keys a second time, the unit will not detect the USB.
6. After pressing the keys twice, the unit shall recognize the USB and show “download”.
