AN EXCHANGE OF TECHNICAL INFORMATION

Number: TL003 - 2025

Subject: New Menu0118 and Read0517 file Released: March 17, 2025

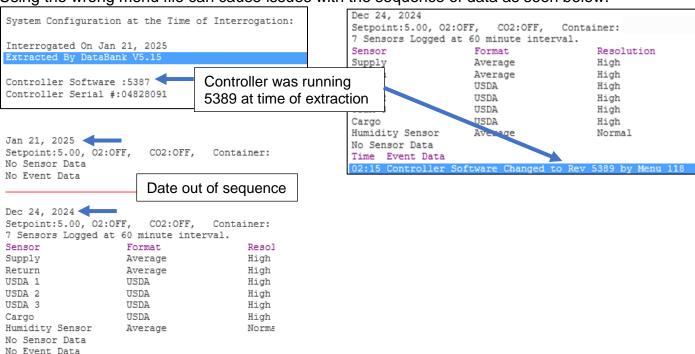
The menu file used when uploading software is posted within the download when viewed with ContainerLINK 3.1 and above. Failure to use the new files can result in data issues. Additionally, downgrading software can also cause data issues in sequencing data (dates/hours) from 5389 or 5190, as seen on the next page.

Using the wrong menu file can cause issues with the sequence of data as seen below.

The new menu and read file are required for Uploads, Downloads, changing model number configuration, container ID, and time while using 5389 or 5190 software or greater.
