Start-Up and Service Instructions

IDENTIFYING DRIVE COMPONENTS

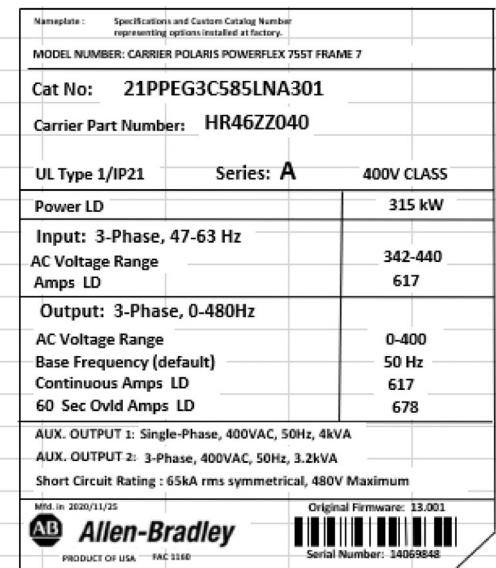
Before calling, have the following information available from the Allen-Bradley data nameplate located inside the enclosure on the right wall. See Fig. 1.

Fig. 1 — Allen Bradley Power Module Data Nameplate

- From the Allen-Bradley nameplate (Fig. 1) located inside the VFD enclosure:
 - Allen-Bradley ID or cat. no.
 - Allen-Bradley serial number
 - Carrier part number

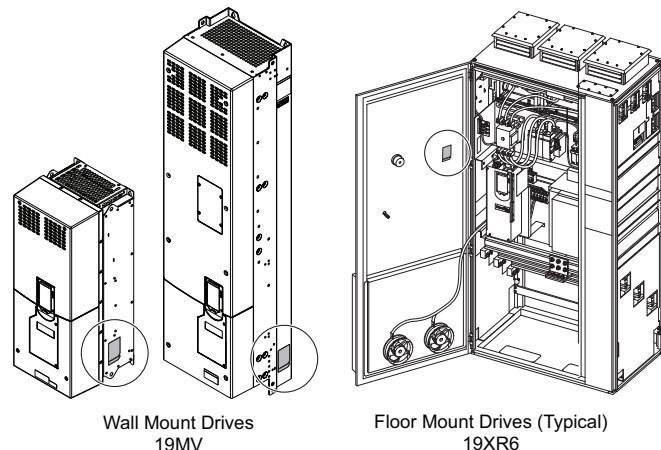
1. Using recommended screwdriver (6.4 mm [0.25 in.] flat or T20 star), open access door. See Fig. 2.
2. Check to be sure that voltage between DC+ and DC- and from each DC terminal to the chassis is zero before proceeding. See Fig. 3.

Fig. 2 — Opening Access Door

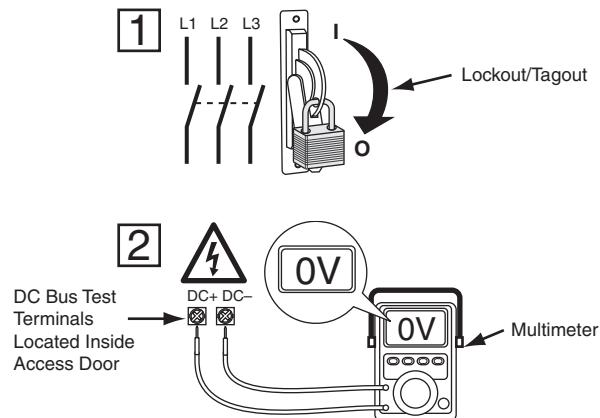
Fig. 3 — Check DC Bus Terminals

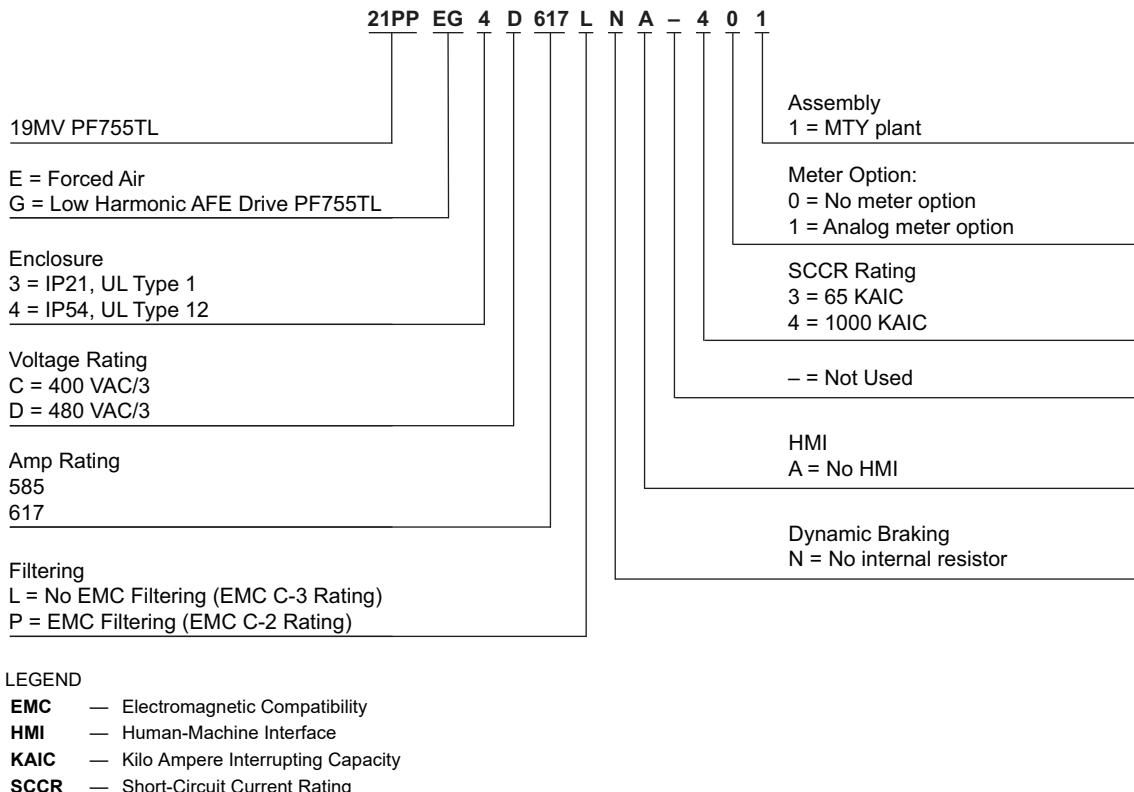
See Fig. 4 and 5 for examples of the Rockwell Automation Drive Assembly Catalog Number.

Fig. 4 — Rockwell Automation Drive Assembly Catalog Number Nomenclature: 19MV Units

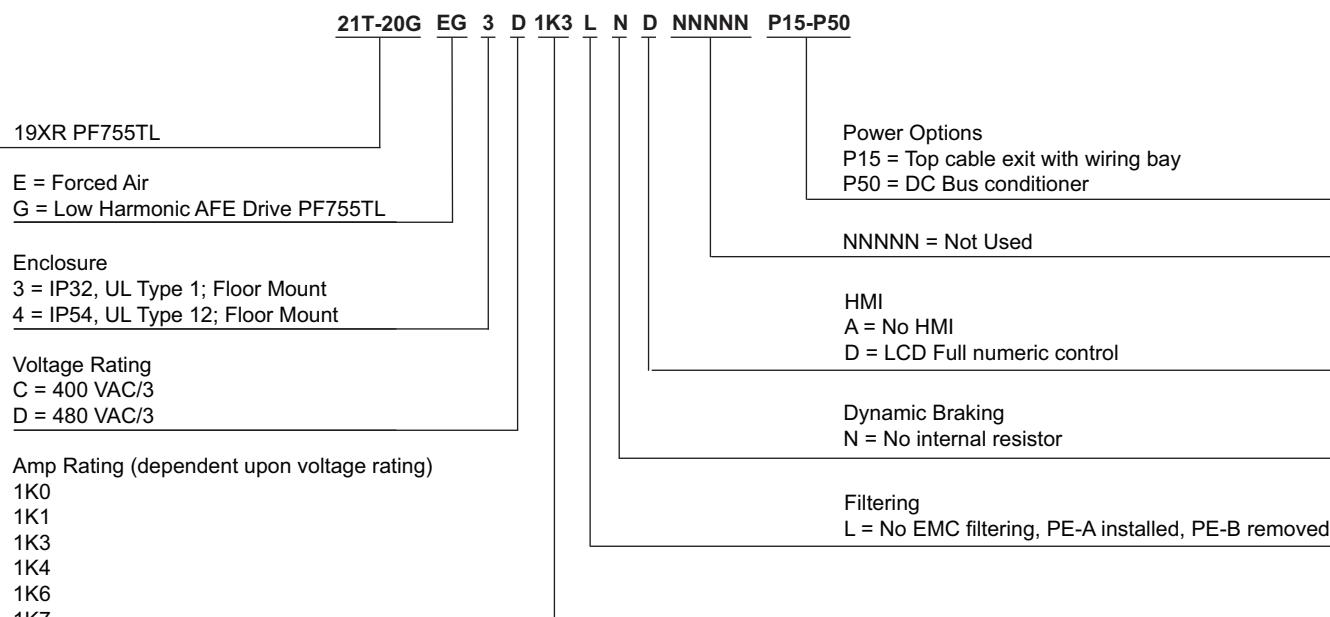
Fig. 5 — Rockwell Automation Drive Assembly Catalog Number Nomenclature: 19XR Units

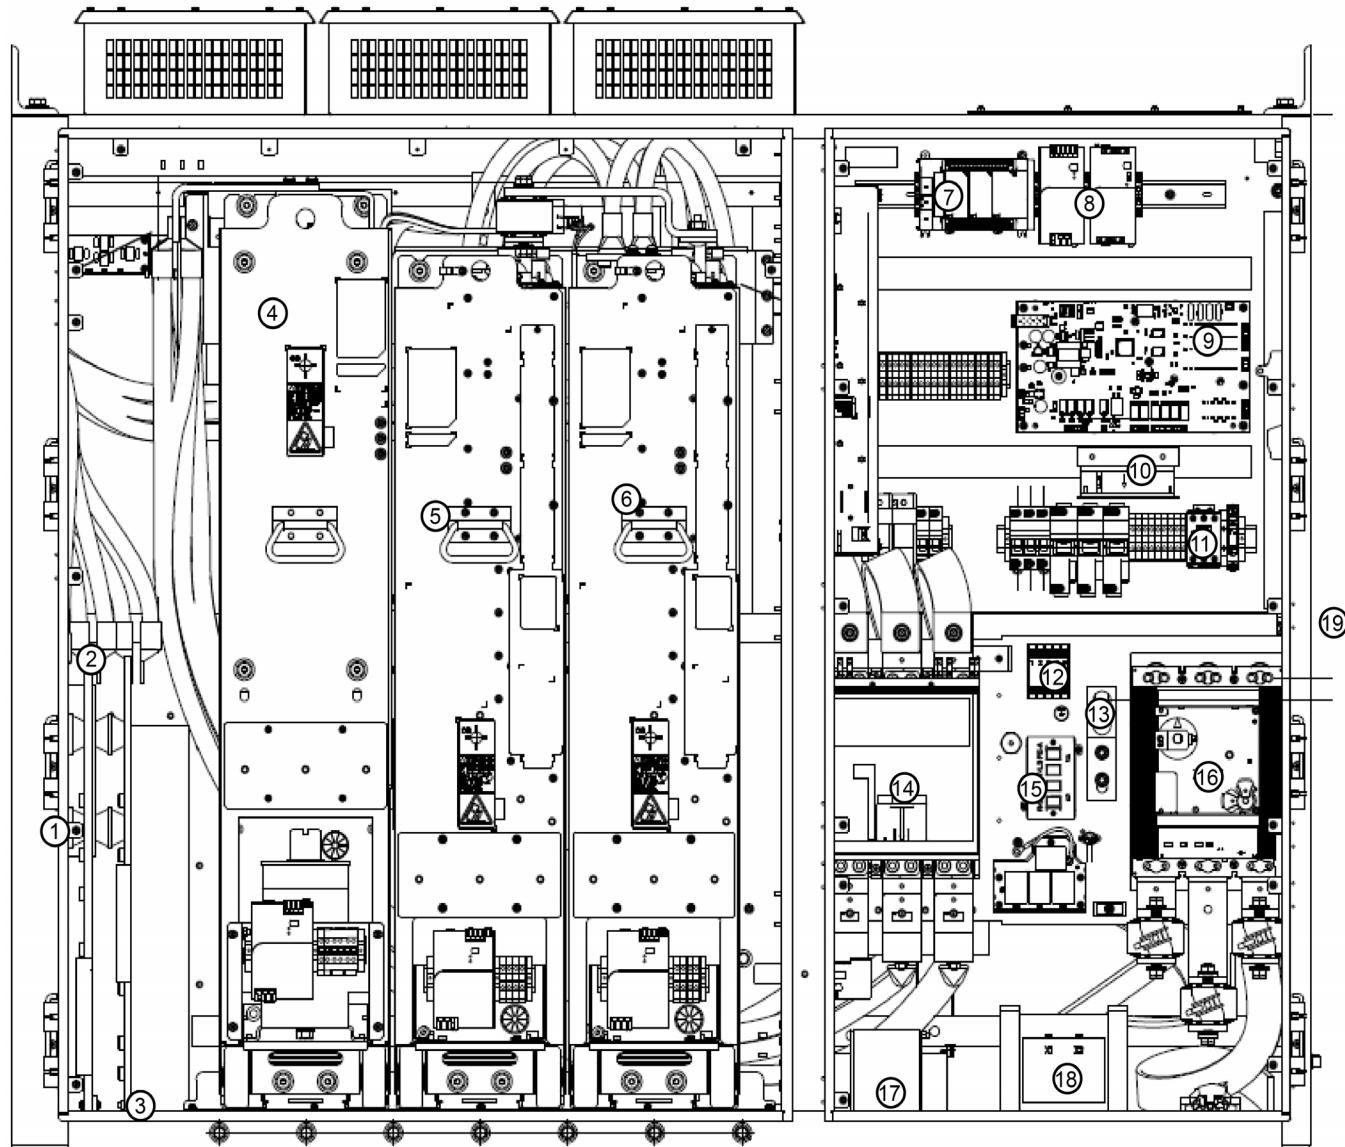
For Allen-Bradley PF755TL drive layout, see Fig. 6 and 7; dimensions are shown in Fig. 8.

Fig. 6 — 19MV Frame 7 PF755TL Drive Components

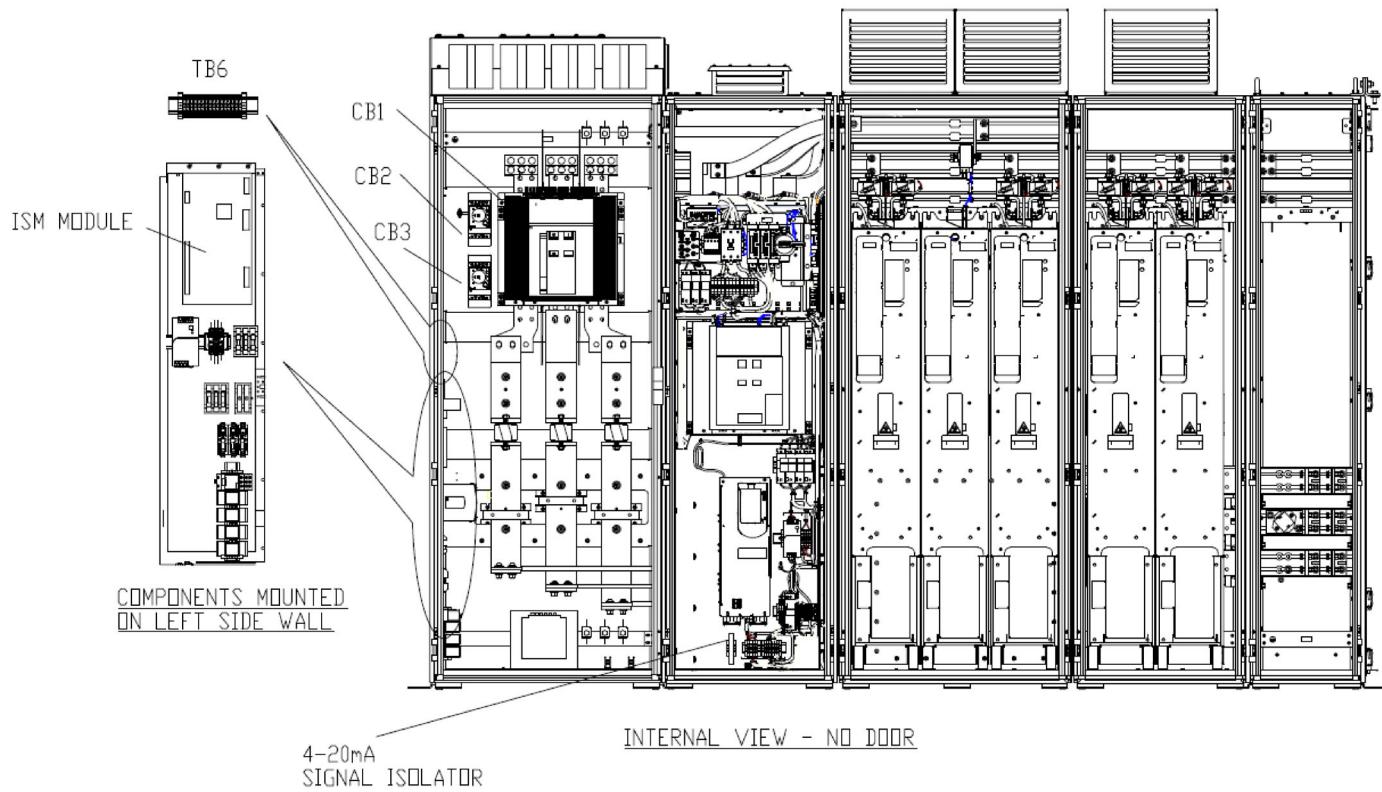
Fig. 7 — 19XR Frame 9 PF755TL Drive Components

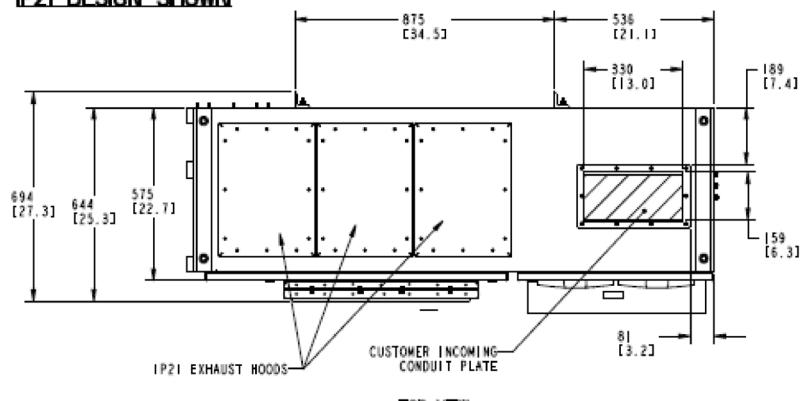
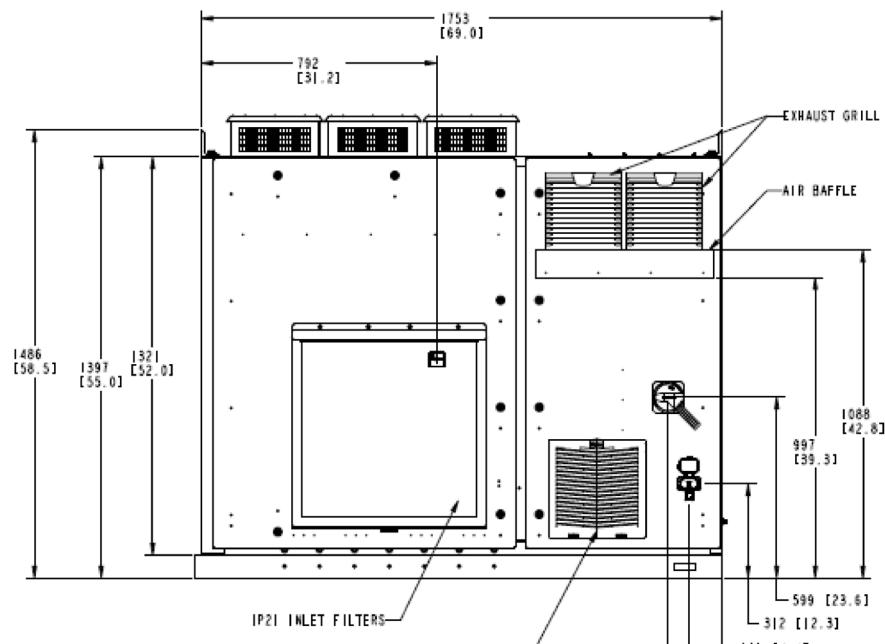
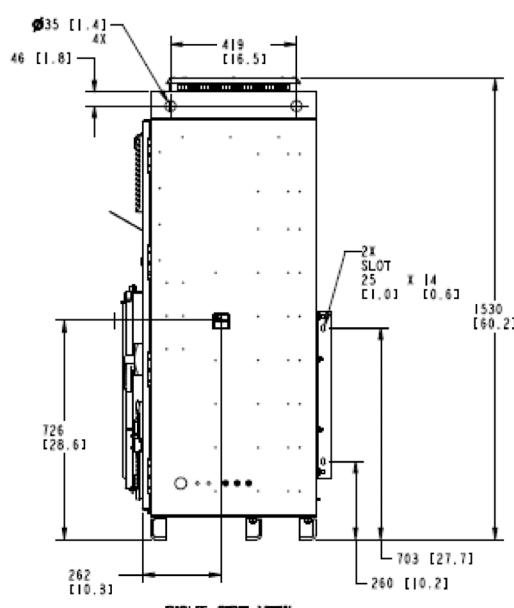
IP21 DESIGN SHOWN

TOP VIEW

FRONT VIEW

NOTE: Dimensions are in mm [in.]

RIGHT SIDE VIEW

Fig. 8 — 19MV Enclosure Dimensions — Frame 7

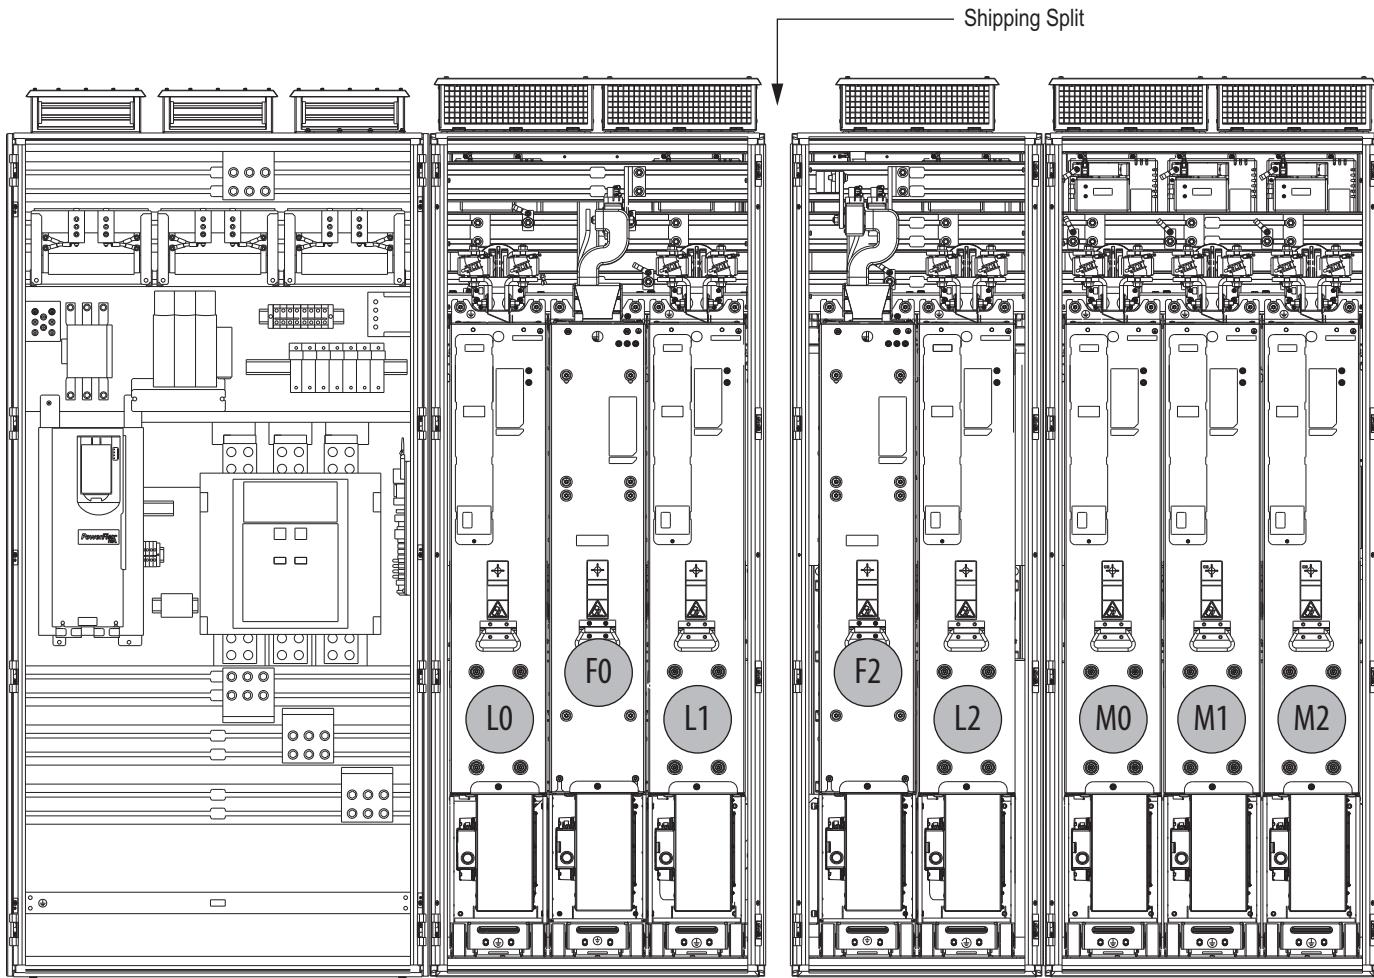
For freestanding PF755TL drive layout, see Fig. 9; dimensions are shown in Fig. 10.

MODULE TYPE	REMOVE POSITION NO.	SHIPPING SPLIT SECTION
LCL Filter	F0	Section 1 of 2 (left section)
Line Side Converter	L0, L1	
LCL Filter	L2	
Motor Side Inverter	F2	Section 2 of 2 (right section)
	M0, M1, M2

Fig. 9 — 19XR Frame 9 PF755TL Layout

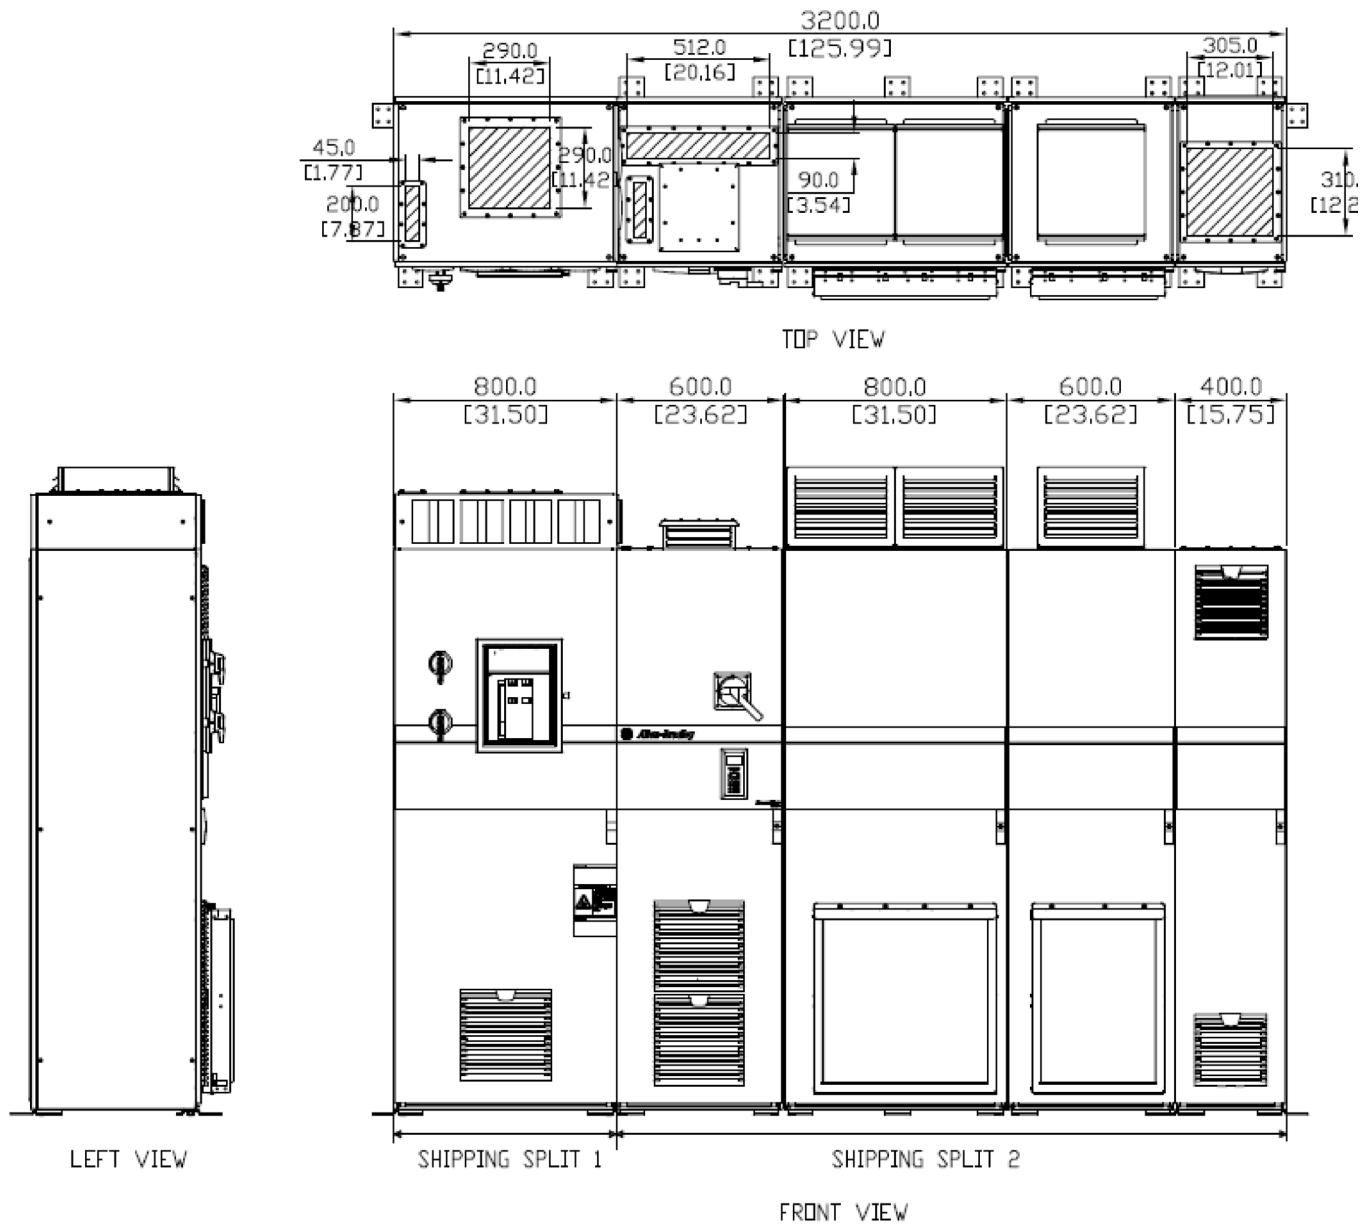
NOTE: Dimensions are in mm [in.]

Fig. 10 — 19XR6 Frame 9 Enclosure Dimensions (Typical)

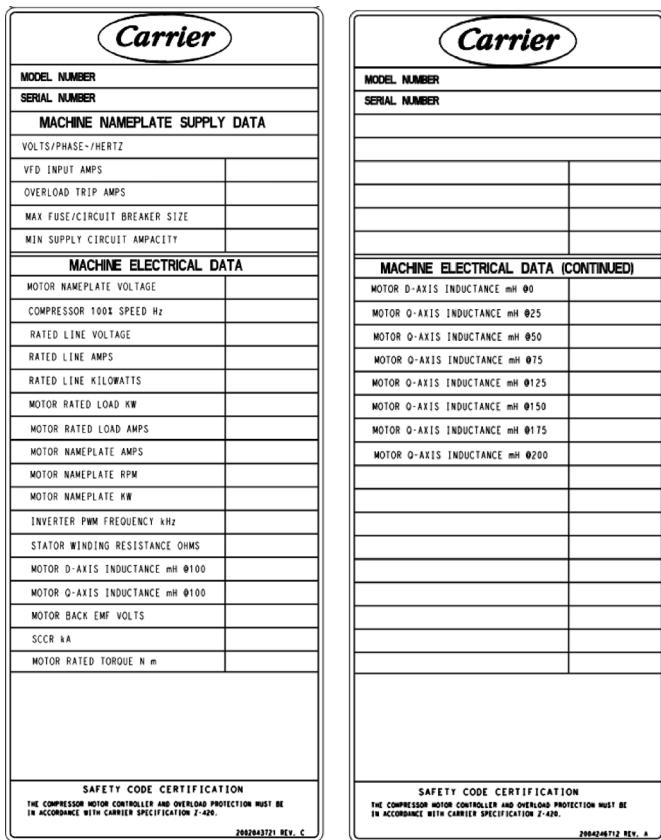
- From the machine nameplate (Fig. 11 or 12) located inside the VFD enclosure:
 - Chiller serial number
 - Chiller model
 - Motor rated load amps
 - Motor nameplate rpm
 - Motor nameplate kW
 - Motor nameplate voltage
 - Inverter PWM (pulse width modulation) frequency
 - Voltage
- From the drive module label located on the drive module:
 - Model or cat. number
 - Serial number
- From the HMI control panel screen:
 - Carrier part number and revision
 - Software number

Fig. 11 — 19MV Nameplate

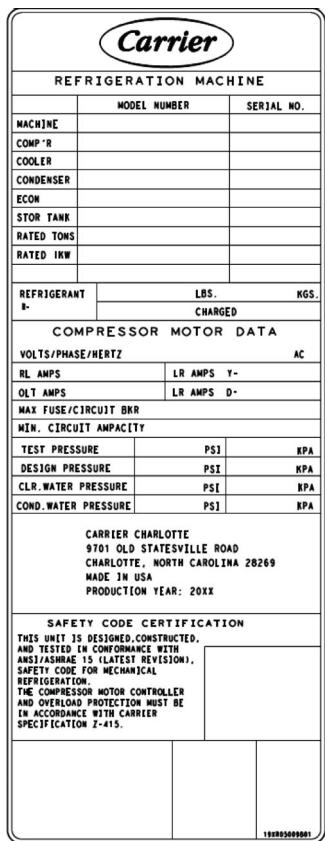
Fig. 12 — 19XR6/7 Nameplate

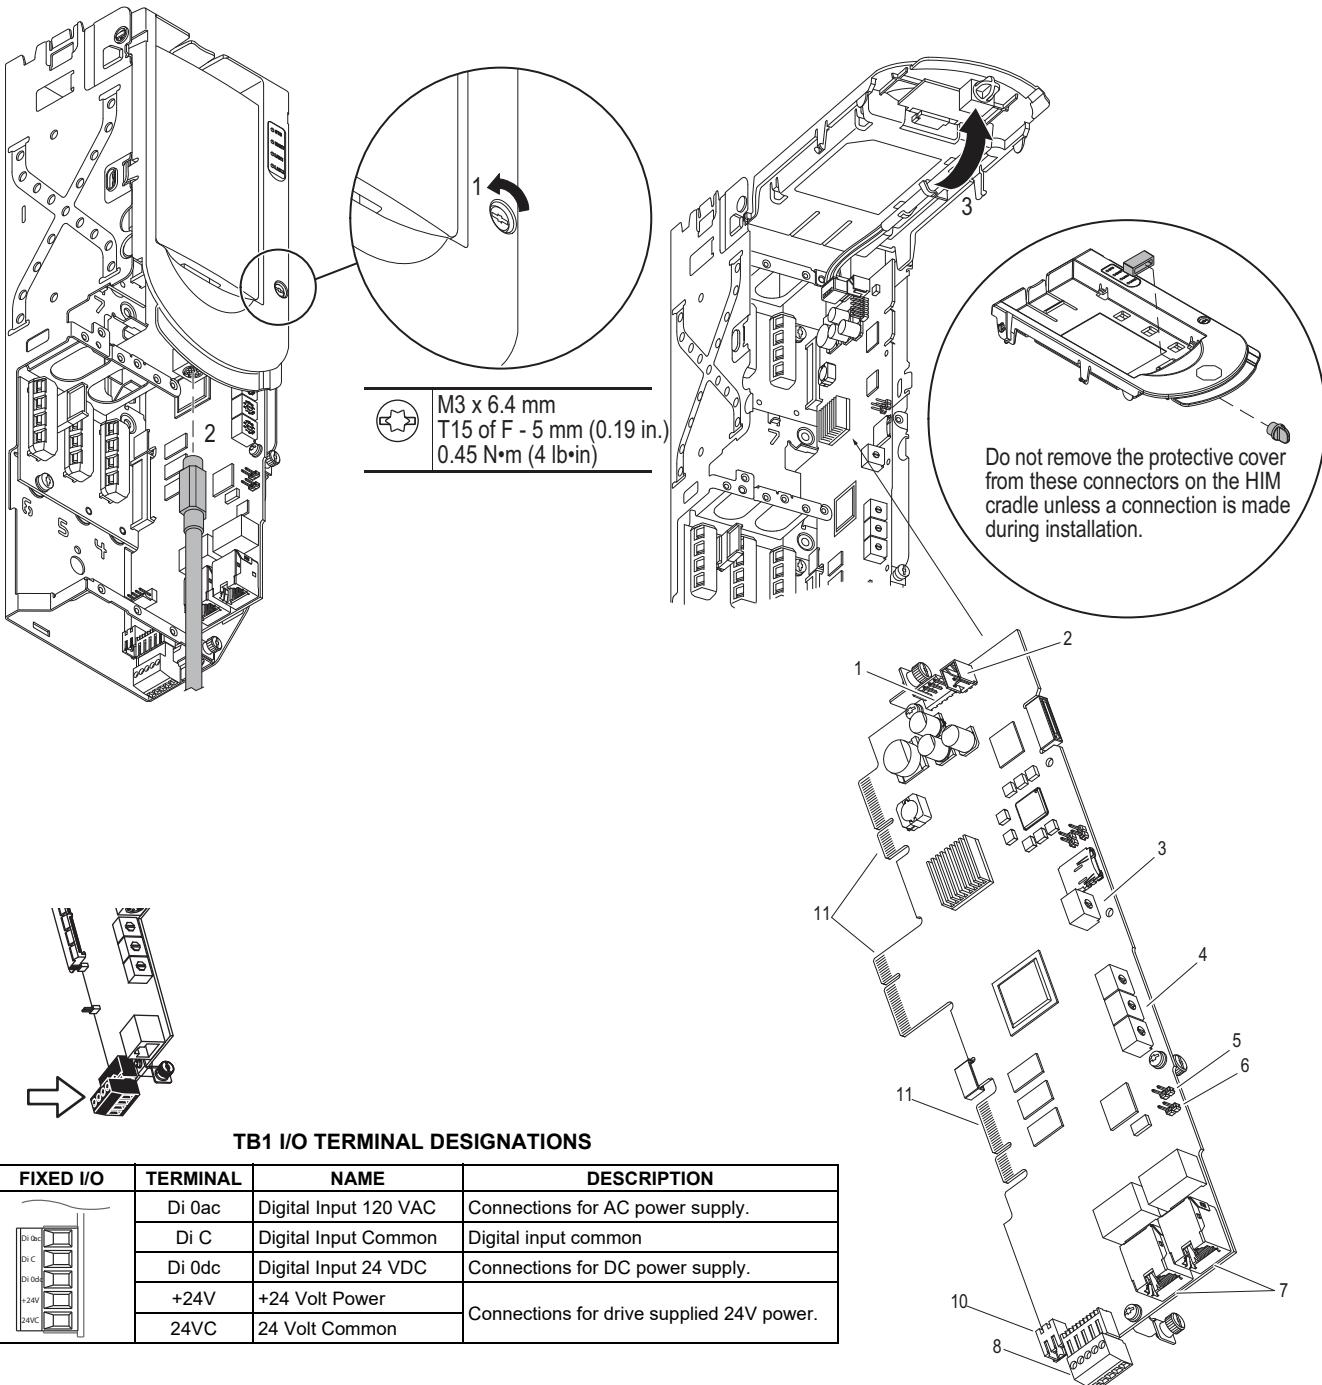
On the Main VFD Control board there are 2 jumpers labeled J1 HARDWARE ENABLE and J2 SAFETY ENABLE. J1 should be removed and J2 should be in place. See Fig. 13.

TB1 I/O TERMINAL DESIGNATIONS

FIXED I/O	TERMINAL	NAME	DESCRIPTION
	Di 0ac	Digital Input 120 VAC	Connections for AC power supply.
	Di C	Digital Input Common	Digital input common
	Di 0dc	Digital Input 24 VDC	Connections for DC power supply.
	+24V	+24 Volt Power	Connections for drive supplied 24V power.
	24VC	24 Volt Common

Fig. 13 — PF755L Main Control Board

Unless the IP address of the drive is known, it is recommended to observe the actual setting of the dial switches. Base is 192.168.1.XXX (Item 4 on Fig. 13). It is recommended to do a ping test between the drive and the computer prior to starting CCW to ensure that there is zero percent loss between drive and computer. In Fig. 23 the IP address is identified as 192.168.1.19 and the computer IP address is configured for 192.168.1.100.

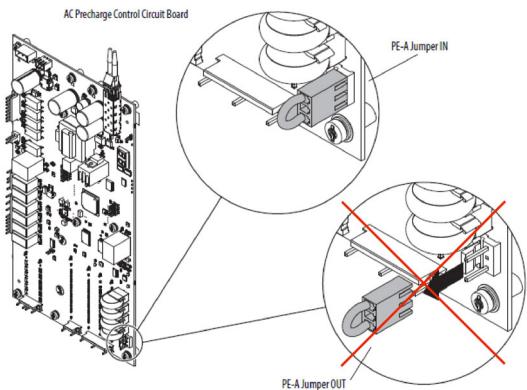
Fig. 14 — 19MV, Frame 7, PE-A MOV on AC Precharge Control Circuit Board

M6 x 10 mm
T30
5.9 N·m (52 lb·in)

- PE-A - MOV on the AC precharge control circuit board
- PE-A1 - MOV on the TVSS (Transient Voltage Surge Suppressor) module
- PE-A2 - Common mode capacitors on the AC common mode filter circuit board
- DR - DC bus conditioner capacitor discharge resistor

See Fig. 14-17. For solidly grounded equipment these are all connected (jumper IN). For any other ground system consult Service Engineering. Default power jumper settings are all connected (jumper IN); jumper OUT is marked with a red X in the figures.

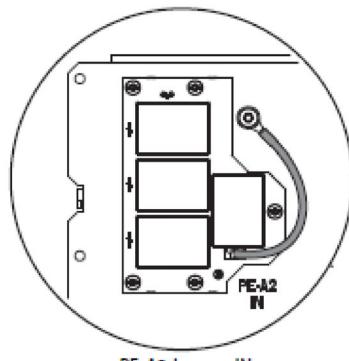
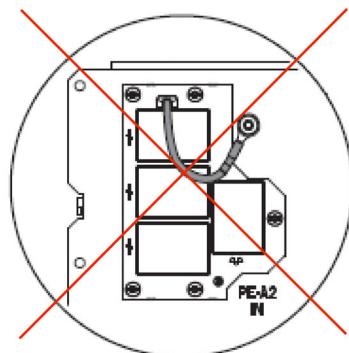
PE-A2 Jumper IN

PE-A2 Jumper OUT

Fig. 16 — 19MV, Frame 7, PE-A2, Capacitors on AC Common Mode Filter Circuit Board

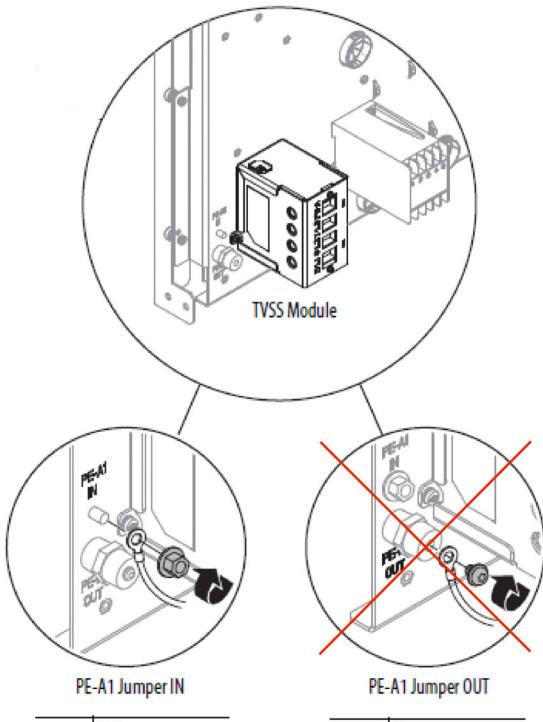
Fig. 15 — 19MV, Frame 7, PE-A1 MOV on TVSS

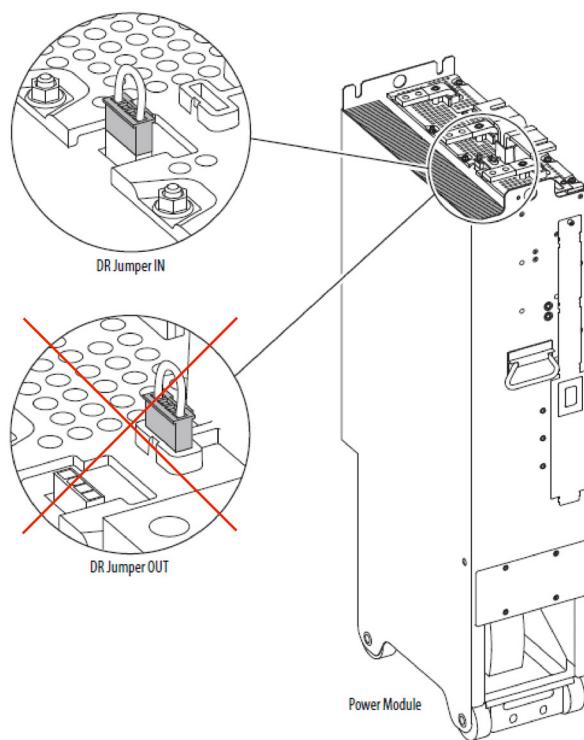
Fig. 17 — 19MV, Frame 7, DC Bus Conditioner Capacitor Discharge Resistor

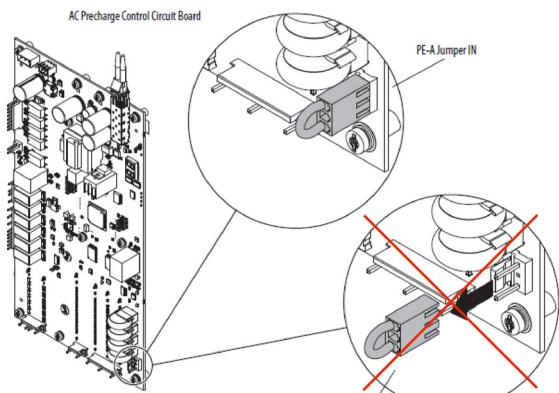
Fig. 18 — 19XR, Frame 9, 10, and Larger, PE-A MOV on AC Precharge Control Circuit Board

- PE-A - MOV on the AC precharge control circuit board
- PE-A1 - MOV on the TVSS module
- PE-A2 - Common mode capacitors on the AC common mode filter circuit board
- PE-B1 - Common mode capacitors on the line side and motor side power interface circuit boards.

For solidly grounded equipment PE-A, PE-A1, PE-A2 are all connected (in) and PE-B1 is disconnected (out). This is the default setting for the drive. For high resistance ground system all jumpers are disconnected (out). High resistance ground systems applications are non-standard and should be reviewed with Service Engineering/Technical Service Manager and may affect warranty. See Fig. 18-21.

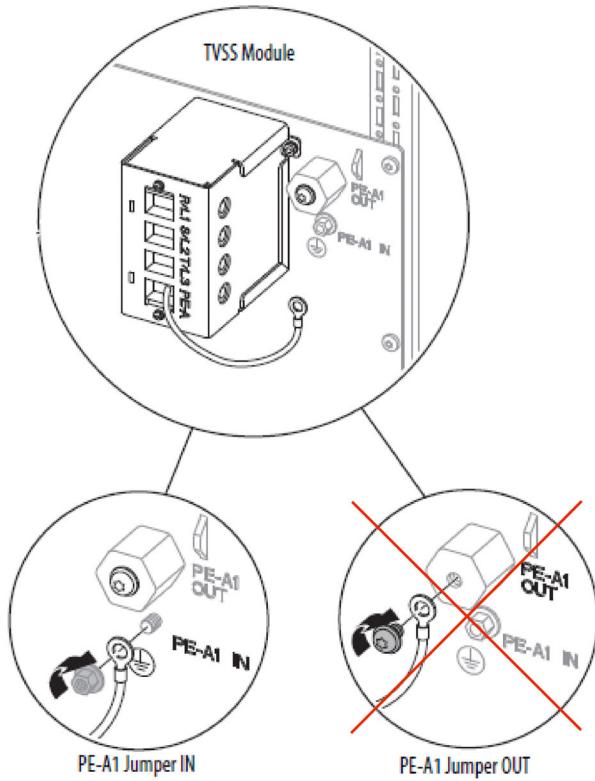
M6 10 mm 10.2 N·m (90 lb·in)
--	------------------------------------

M6 x 10 mm T25 5.9 N·m (52 lb·in)
--	---

Fig. 19 — 19XR, Frame 9, 10, and Larger, PE-A1 MOV on TVSS

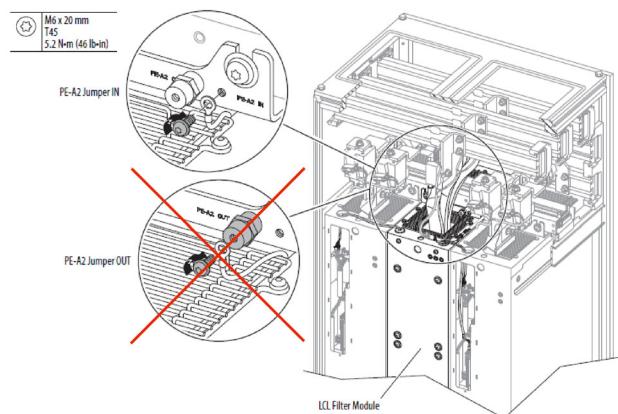
Fig. 20 — 19XR, Frame 9, 10, and Larger, PE-A2, Capacitors on AC Common Mode Filter Circuit Board

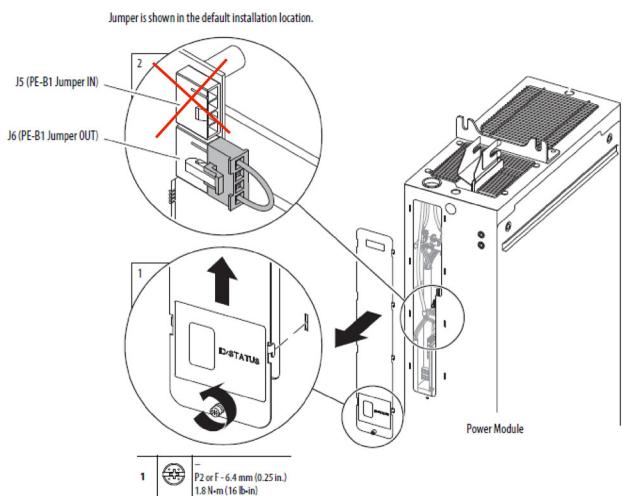
Fig. 21 — 19XR, Frame 9, 10, and Larger, PE-B1, Common Mode Capacitors on Line Side and Motor Side Power Interface Circuit Boards

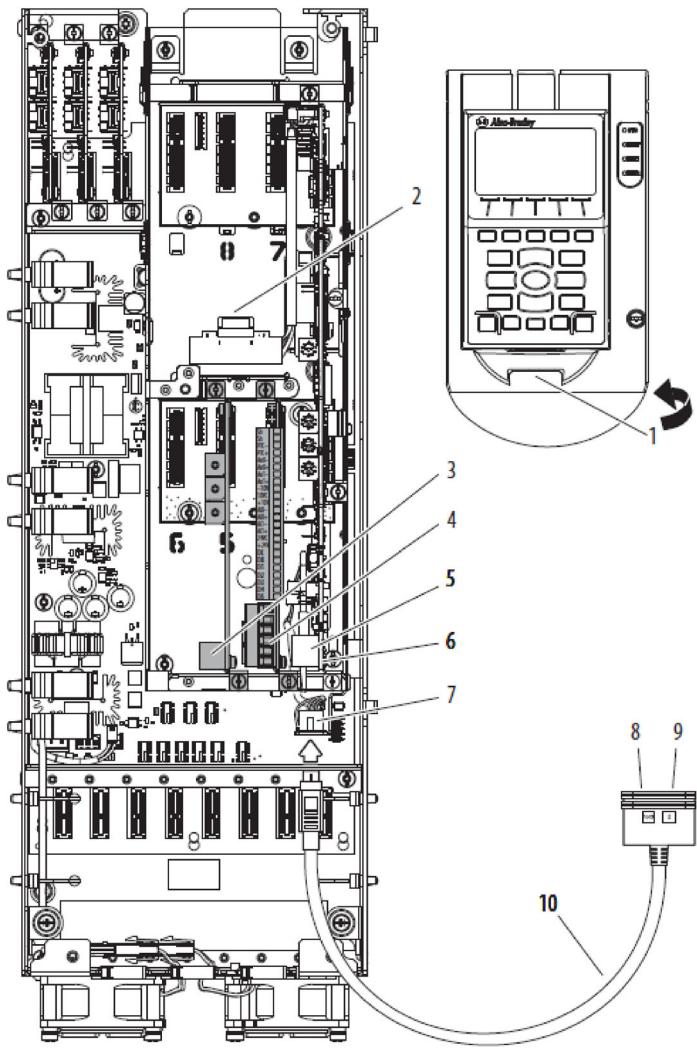
Fig. 22 — PF755TL Control Pod Assembly

- VFD Faults/Alarms can be viewed using Rockwell Automation Connected Components Workbench (CCW) program, which can be downloaded from their website.
- A failure resulting in a shutdown is seen as an ALARM on the HMI and as a VFD FAULT when viewed with CCW. See Tables 4-5 and Fig. 22.

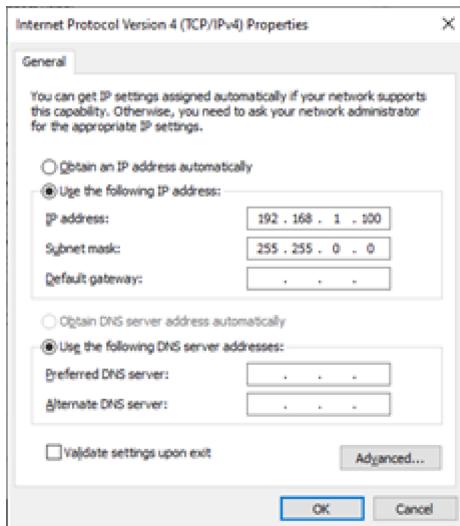
To connect a computer to CCW via Ethernet, the user has to set the connection IP address to something similar as the drive and same subnet mask. See Fig. 23.

Fig. 23 — Computer Configuration Example

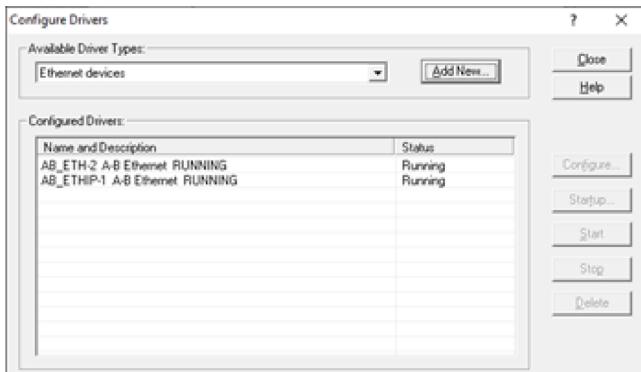
1. When starting CCW go to Communications drop down and select Configure Drivers. See Fig. 24.

Fig. 24 — Configure Drivers

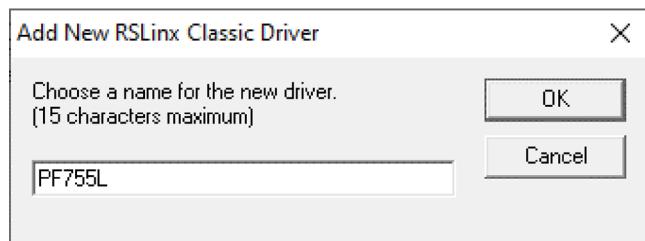
2. Select “Add New” driver and give it a unique name, then click OK. See Fig. 25.

Fig. 25 — Add New Driver

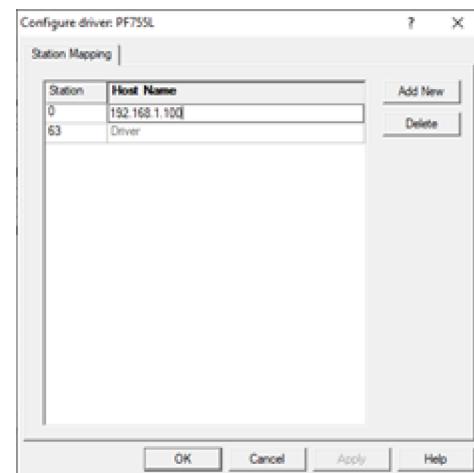
3. Set Host to the same address as the computer IP address. See Fig. 26.

Fig. 26 — Station Mapping

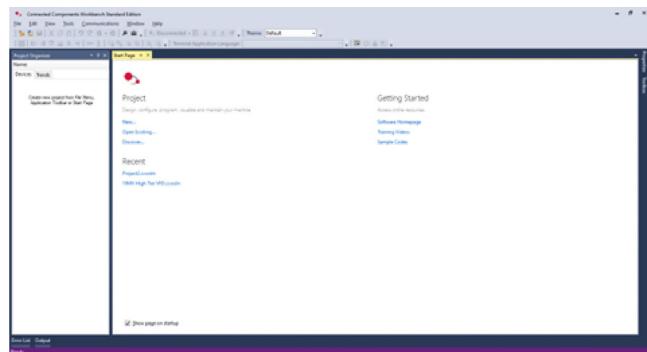
4. Once the communication driver is set up, select Discover in CCW and select the appropriate device. See Fig. 27 and 28.

Fig. 27 — CCW Discover Device

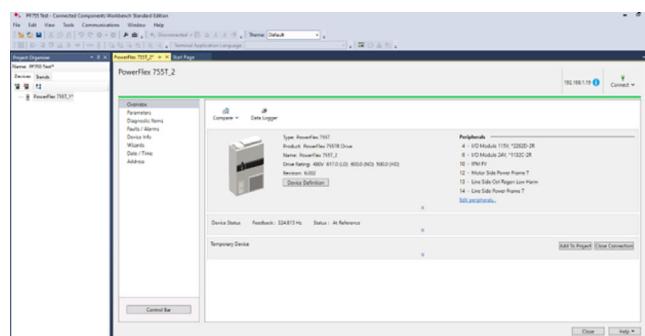
Fig. 28 — CCW Device Example: 19MV Frame 7 PF755TL

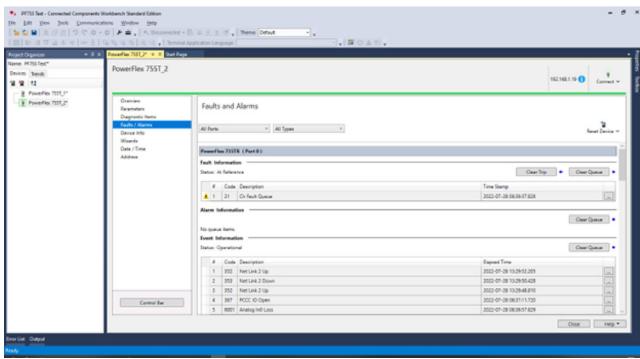
- To see faults, select Faults/Alarms from left side menu. The fault can also be cleared from this menu by selecting “Clear Trip.” See Fig. 29.

Fig. 29 — CCW Faults and Alarms

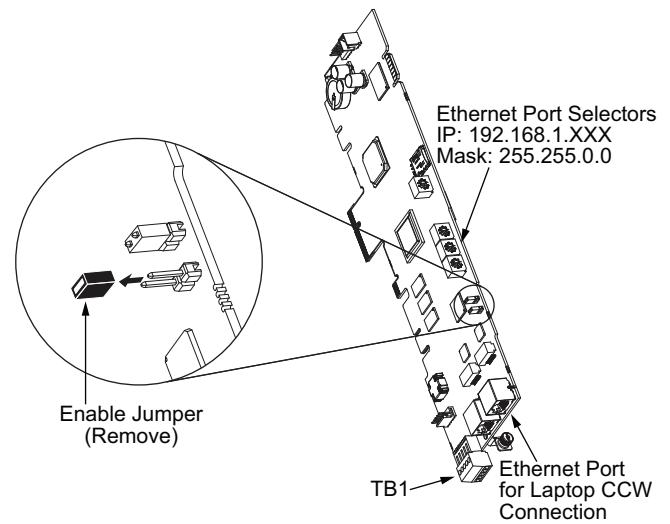
Figure 30 shows the drive module with the cover removed. To access the control boards, loosen the screw on the face of the keypad mount and swing the keypad mount upward.

Fig. 30 — Drive Module with Cover Removed

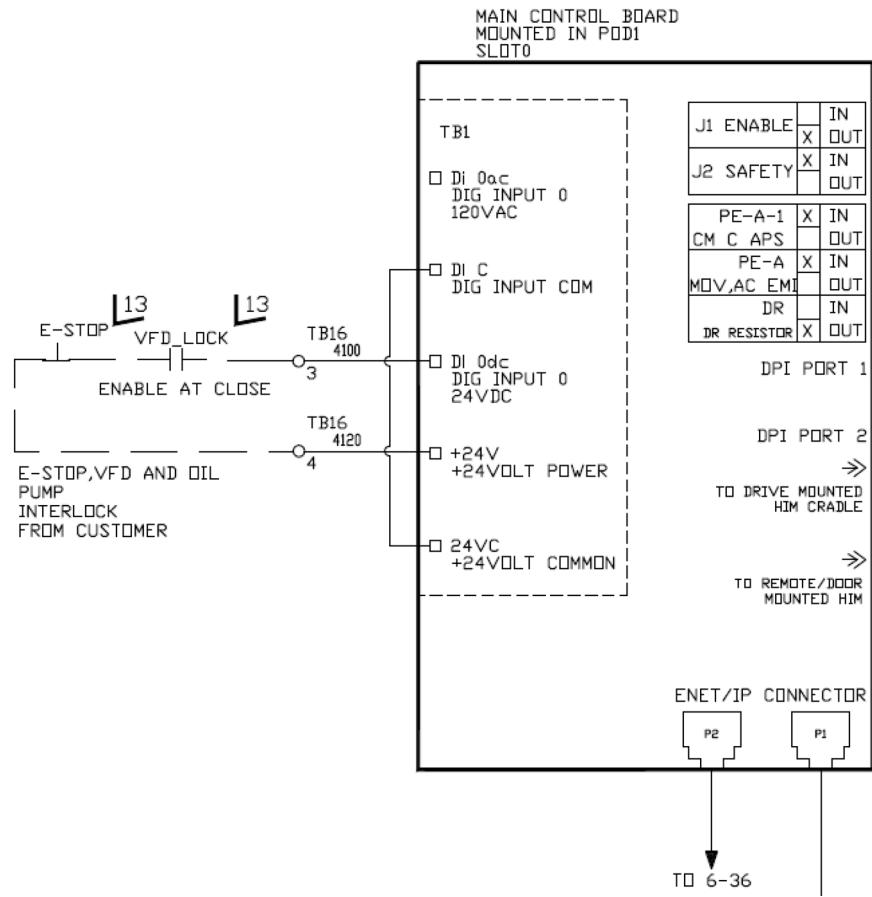
The components on the main control board (MCB) are shown in Fig. 31 and 32. As previously indicated insure J1 Enable Jumper is OUT and J2 Safety jumper is IN. The main control board has one digital input 0. This is used as a dedicated hardware enable that are unaffected by drive parameter settings with the ENABLE jumper removed.

Fig. 31 — 19MV Main Control Board

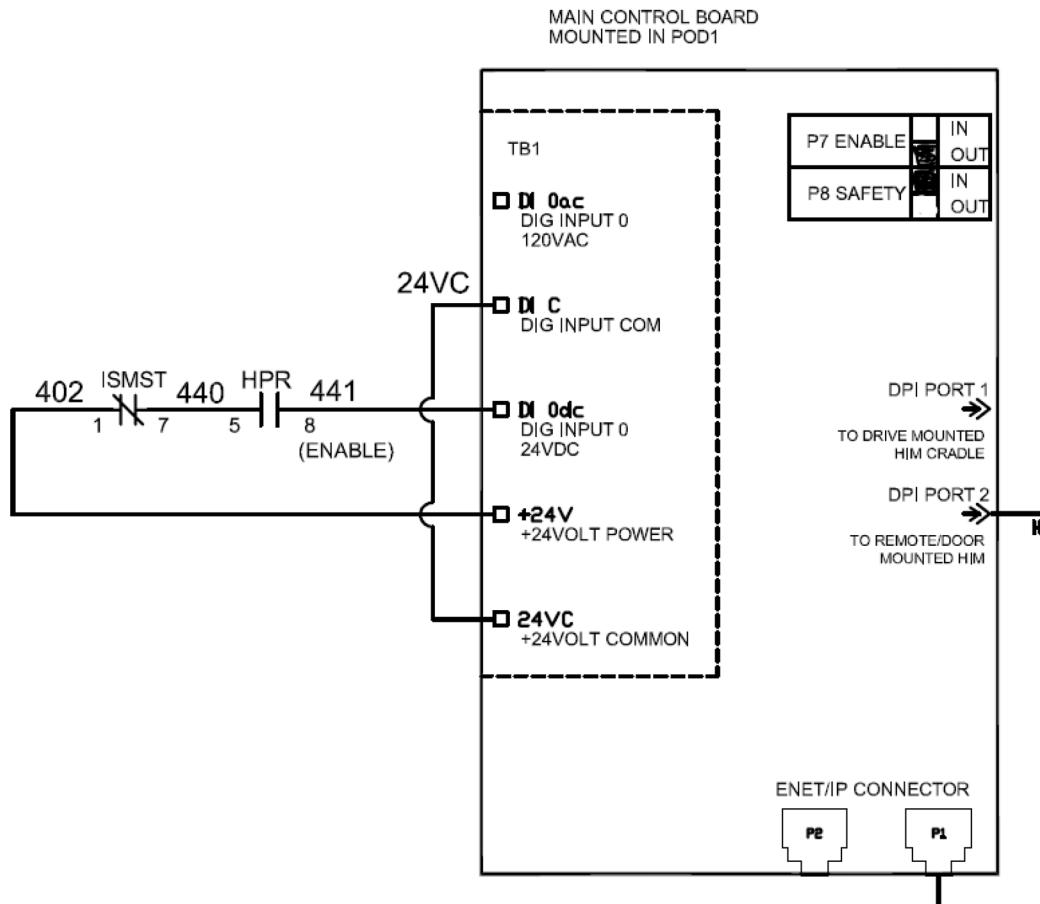
Fig. 32 — 19XR Main Control Board

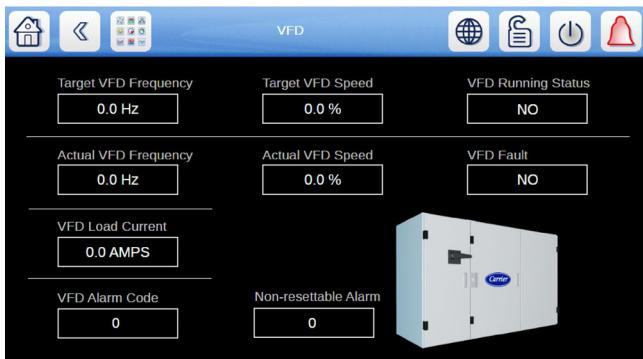
The 19MV and 19XR unit mount PF755TL drive communicates with PIC6 using Modbus protocol. If the VFD goes into fault, the actual VFD fault will be displayed on the VFD status screen. See Fig. 33.

Fig. 33 — VFD Screen

The actual VFD Alarm Code will be displayed in the bottom left. Be sure to collect this code along with the code the PIC6 displays as the current alarm.

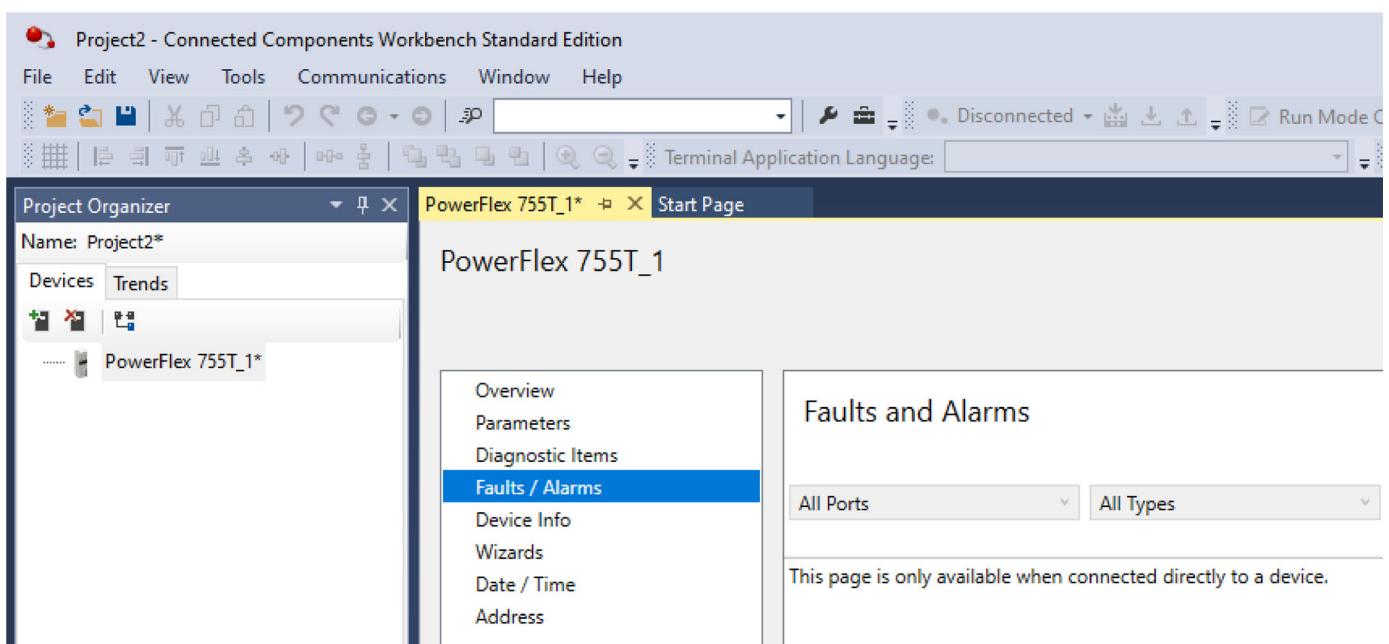
The 19XR PF755TL and free-standing drive does not have direct communication with PIC6. Interface between drive and PIC6 is via ISM (integrated starter module). Therefore CCW must be used to find the actual VFD fault in case of VFD shutdown. The PIC6 controller will just display a generic starter fault like Alarm 416 ISM Fault — Starter Fault. For further troubleshooting the actual VFD fault is required. See Fig. 34.

Fig. 34 — VFD Alarm Code

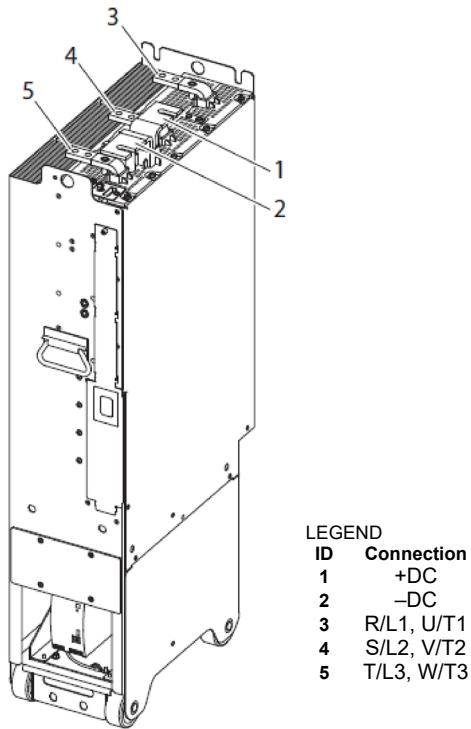
Fig. 35 — Frame 7 Power Module

1. Turn off and lock out input power. Wait 5 minutes.
2. Verify there is no voltage at the drive's input power terminals.
3. Using a voltmeter, check the DC bus potential as described in the section Verifying That DC Bus Capacitors Are Discharged on page 21 to ensure the DC bus capacitors are discharged.
4. Check all AC line and DC bus fuses.
5. Use a multimeter to check the input diodes and output IGBTs if a fuse is open. See Table 8. Multimeter must have a function to select "Diode Test" mode. See Fig. 35 for Frame 7 power module (19MV) and Fig. 36 for Frame 8-15 power modules (19XR).
6. Reapply input power.

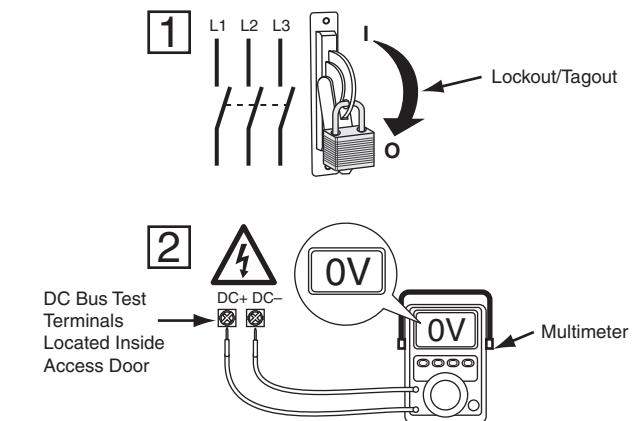
Fig. 37 — Check DC Bus Terminals

Figure 37 illustrates use of a multimeter to check DC bus terminals.
