Start-Up and Service Instructions

IDENTIFYING DRIVE COMPONENTS

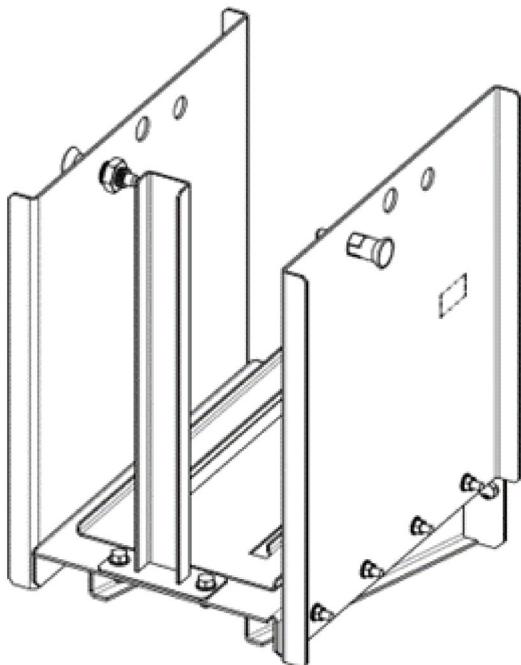
Fig. 38 — PF755TL 19MV Ramp Tool

If service of main drive components is required a ramp assembly tool is required (Fig. 38). It is recommended that access to a ramp assembly tool is available for every jobsite as this tool is required for removal of the LCL, converter or inverter section of the drive.

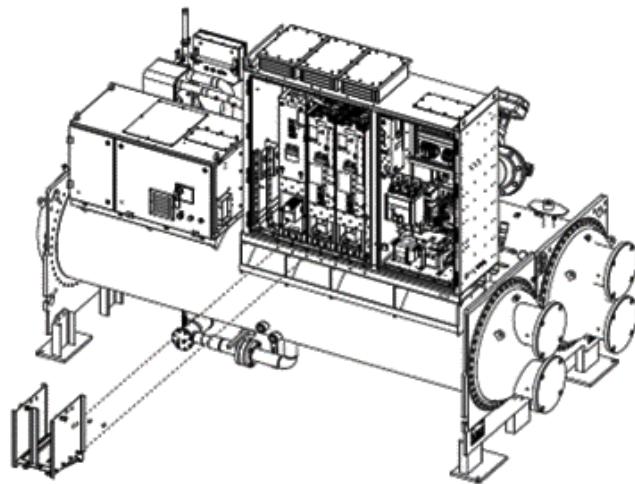
Fig. 39 — Ramp Installation Location

Then install the ramp assembly (Fig. 39). Note that this is a safety device, and that care must be taken to inspect the ramp assembly prior to use and properly attach the ramp to the structure per Fig. 40 or serious bodily injury may occur.

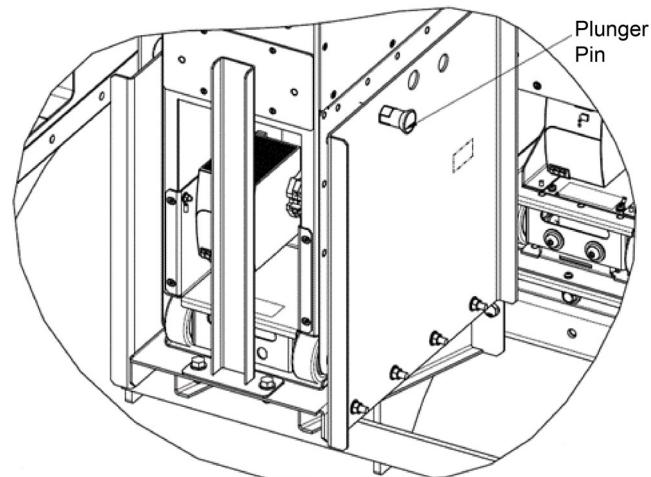
Fig. 41 — Plunger Pins Locking Component in Place

Upon attachment to the VFD structure the LCL, converter or converter can slide onto the ramp and thereby provide access to overhead rigging. Once component is slide out on the ramp a plunger pin can lock the component in position. See Fig. 41.

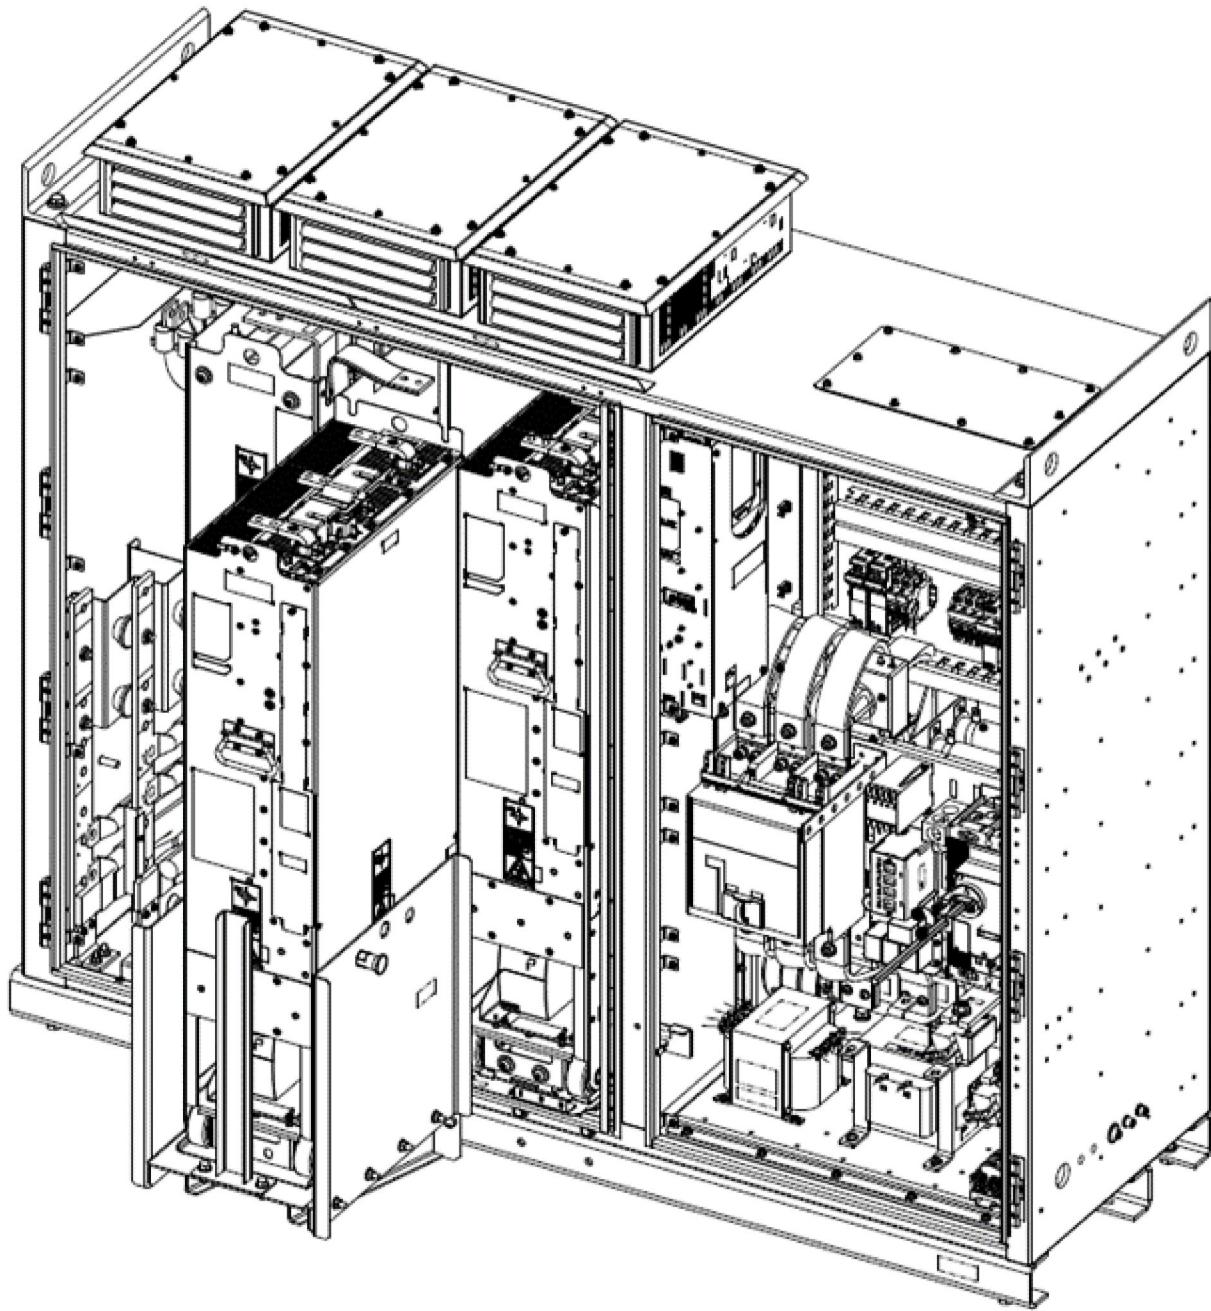
Fig. 42 — Access for Overhead Rigging

The procedure for removal and installation is the same for all 3 major components. Figure 42 shows access for overhead rigging.

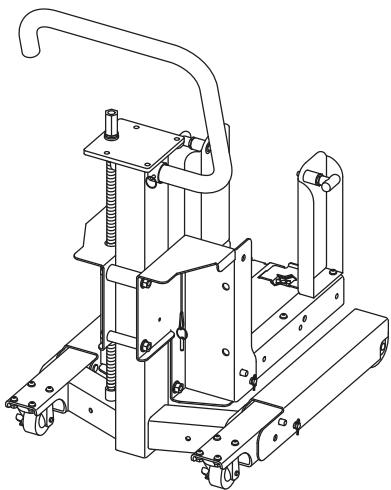
Fig. 43 — Service Cart

For 19XRV Freestanding drives a different tool is used. The same procedure of removing hardware to isolate the LCL, converter, or inverter module is used so the module can slide out and be safely removed from the drive using the PowerFlex 750-Series Service Cart. See Fig. 43.

Rockwell catalog 750-IN105 contains the service cart requirements based on PF755TL size and needs. It is recommended to ensure that a site has access to a service cart as without it the LCL filter modules and power modules cannot be replaced.

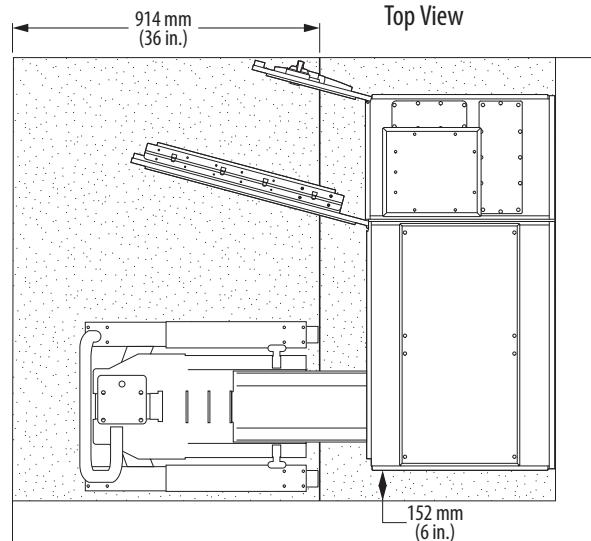
Fig. 44 — Clearance Requirement

Adequate service clearance in front and to the side of a freestanding PF755TL drive is required. See Fig. 44.

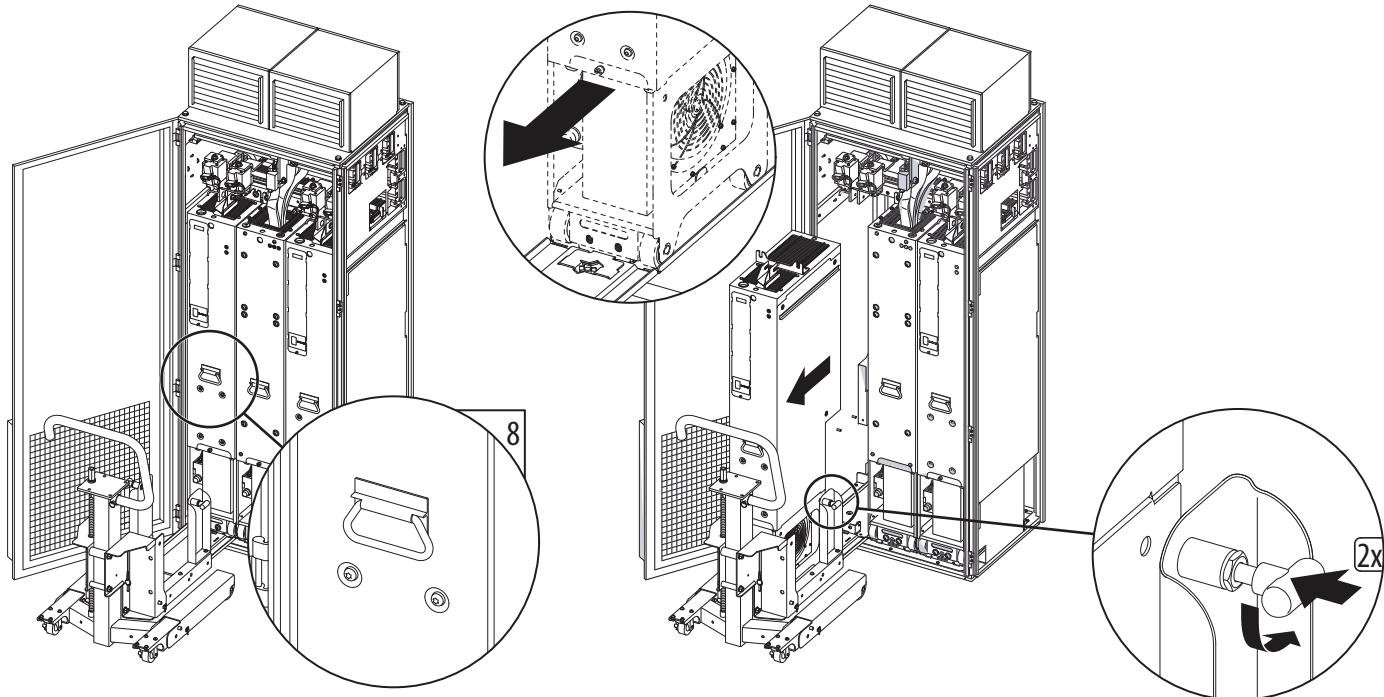
Fig. 45 — Service Cart Use

The service cart (Fig. 45) can be docked in the cabinet (below filter modules) once use is completed.

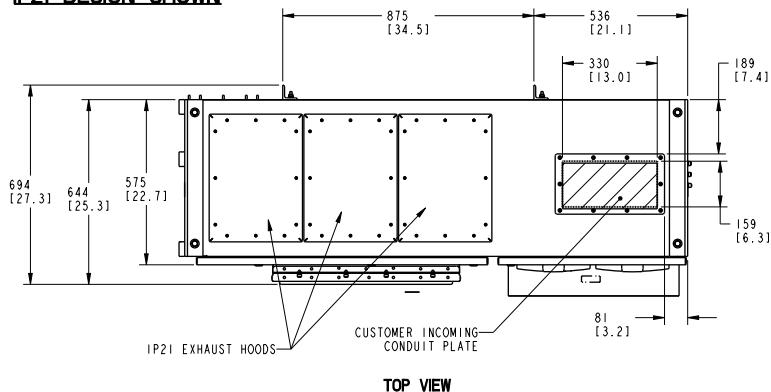
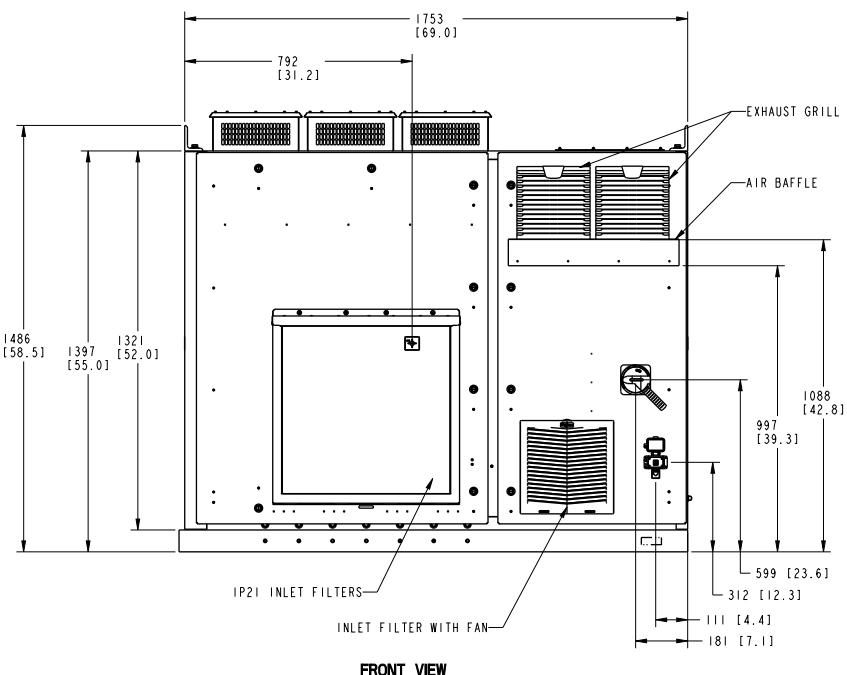
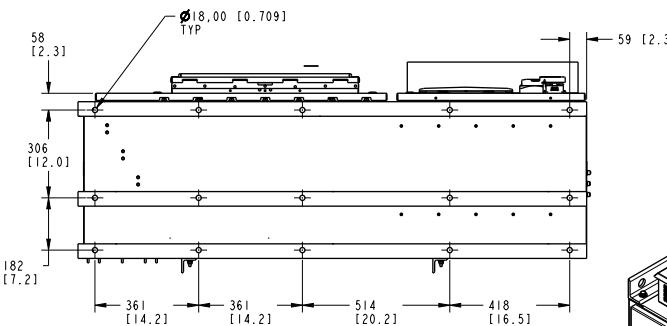
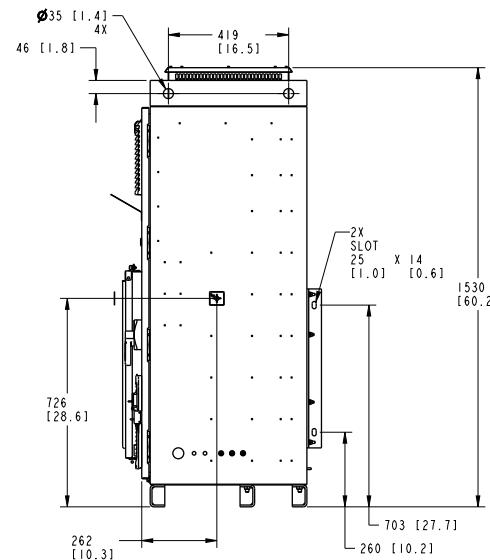
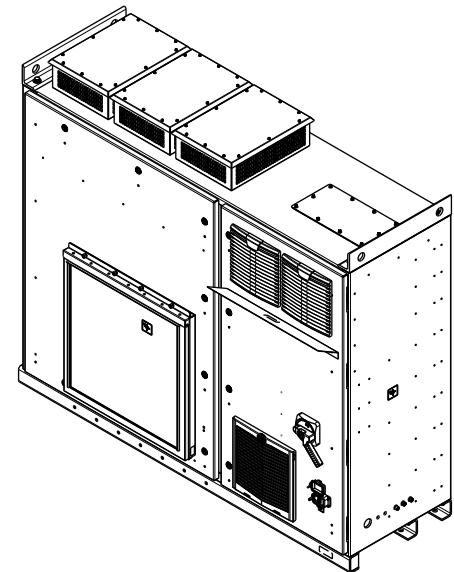
19MV PowerFlex 755TL Layout

IP21 DESIGN SHOWN

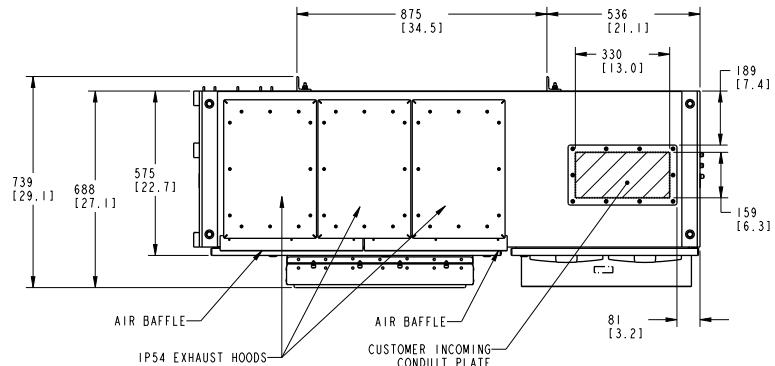
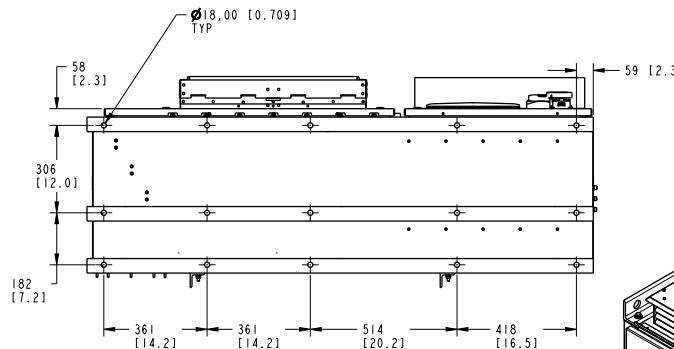
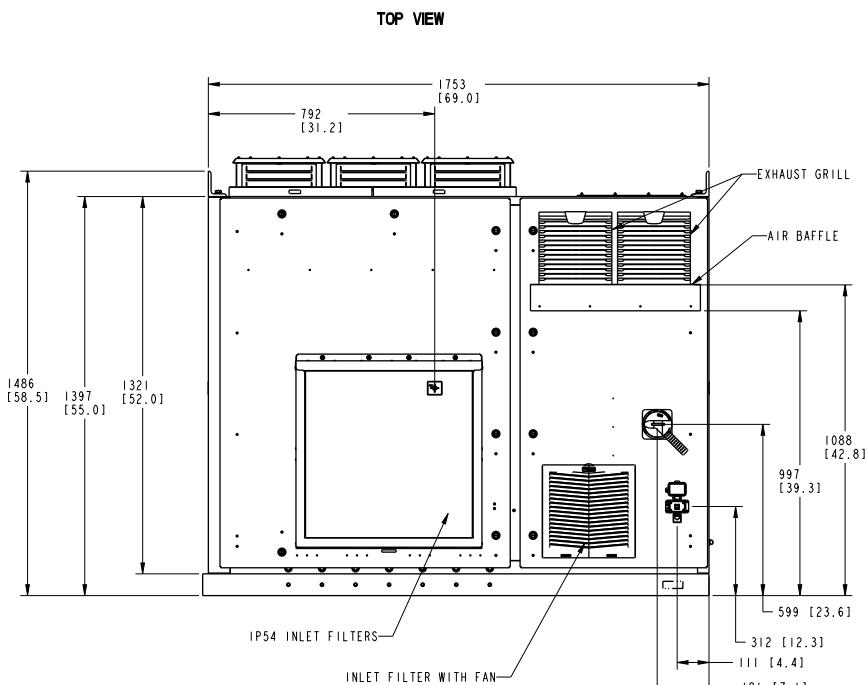
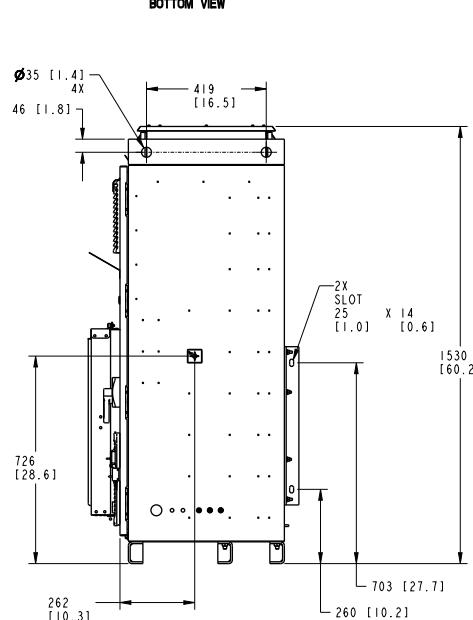
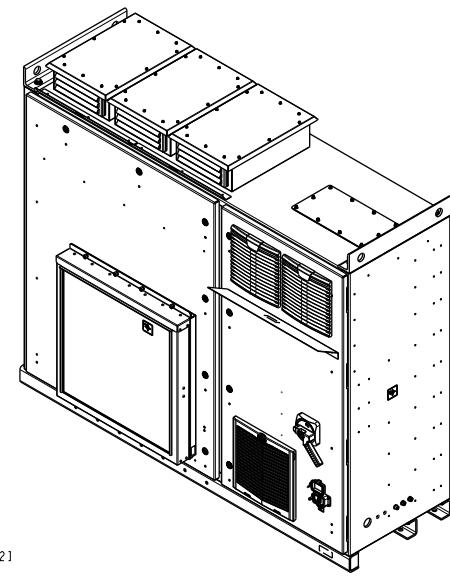
19MV PowerFlex 755TL Layout (cont)

IP54 DESIGN SHOWN

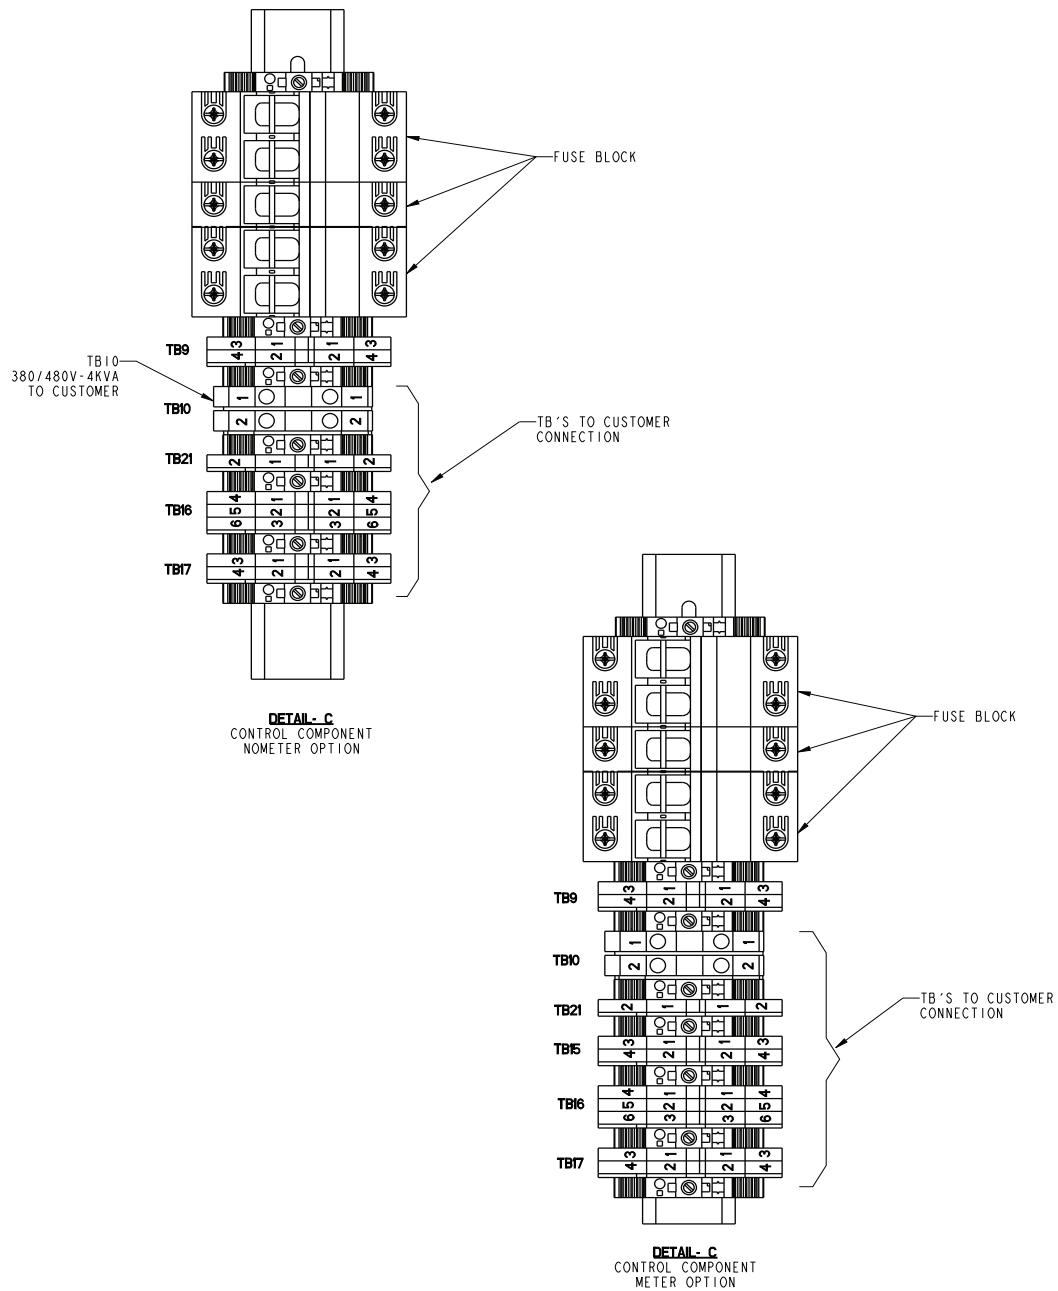
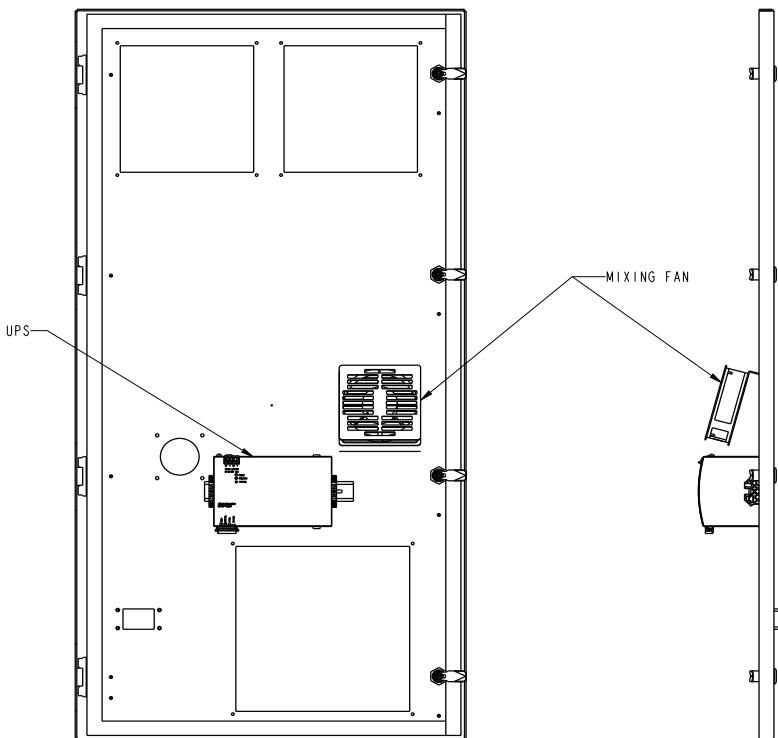
ACPC BAY DOOR REAR VIEW

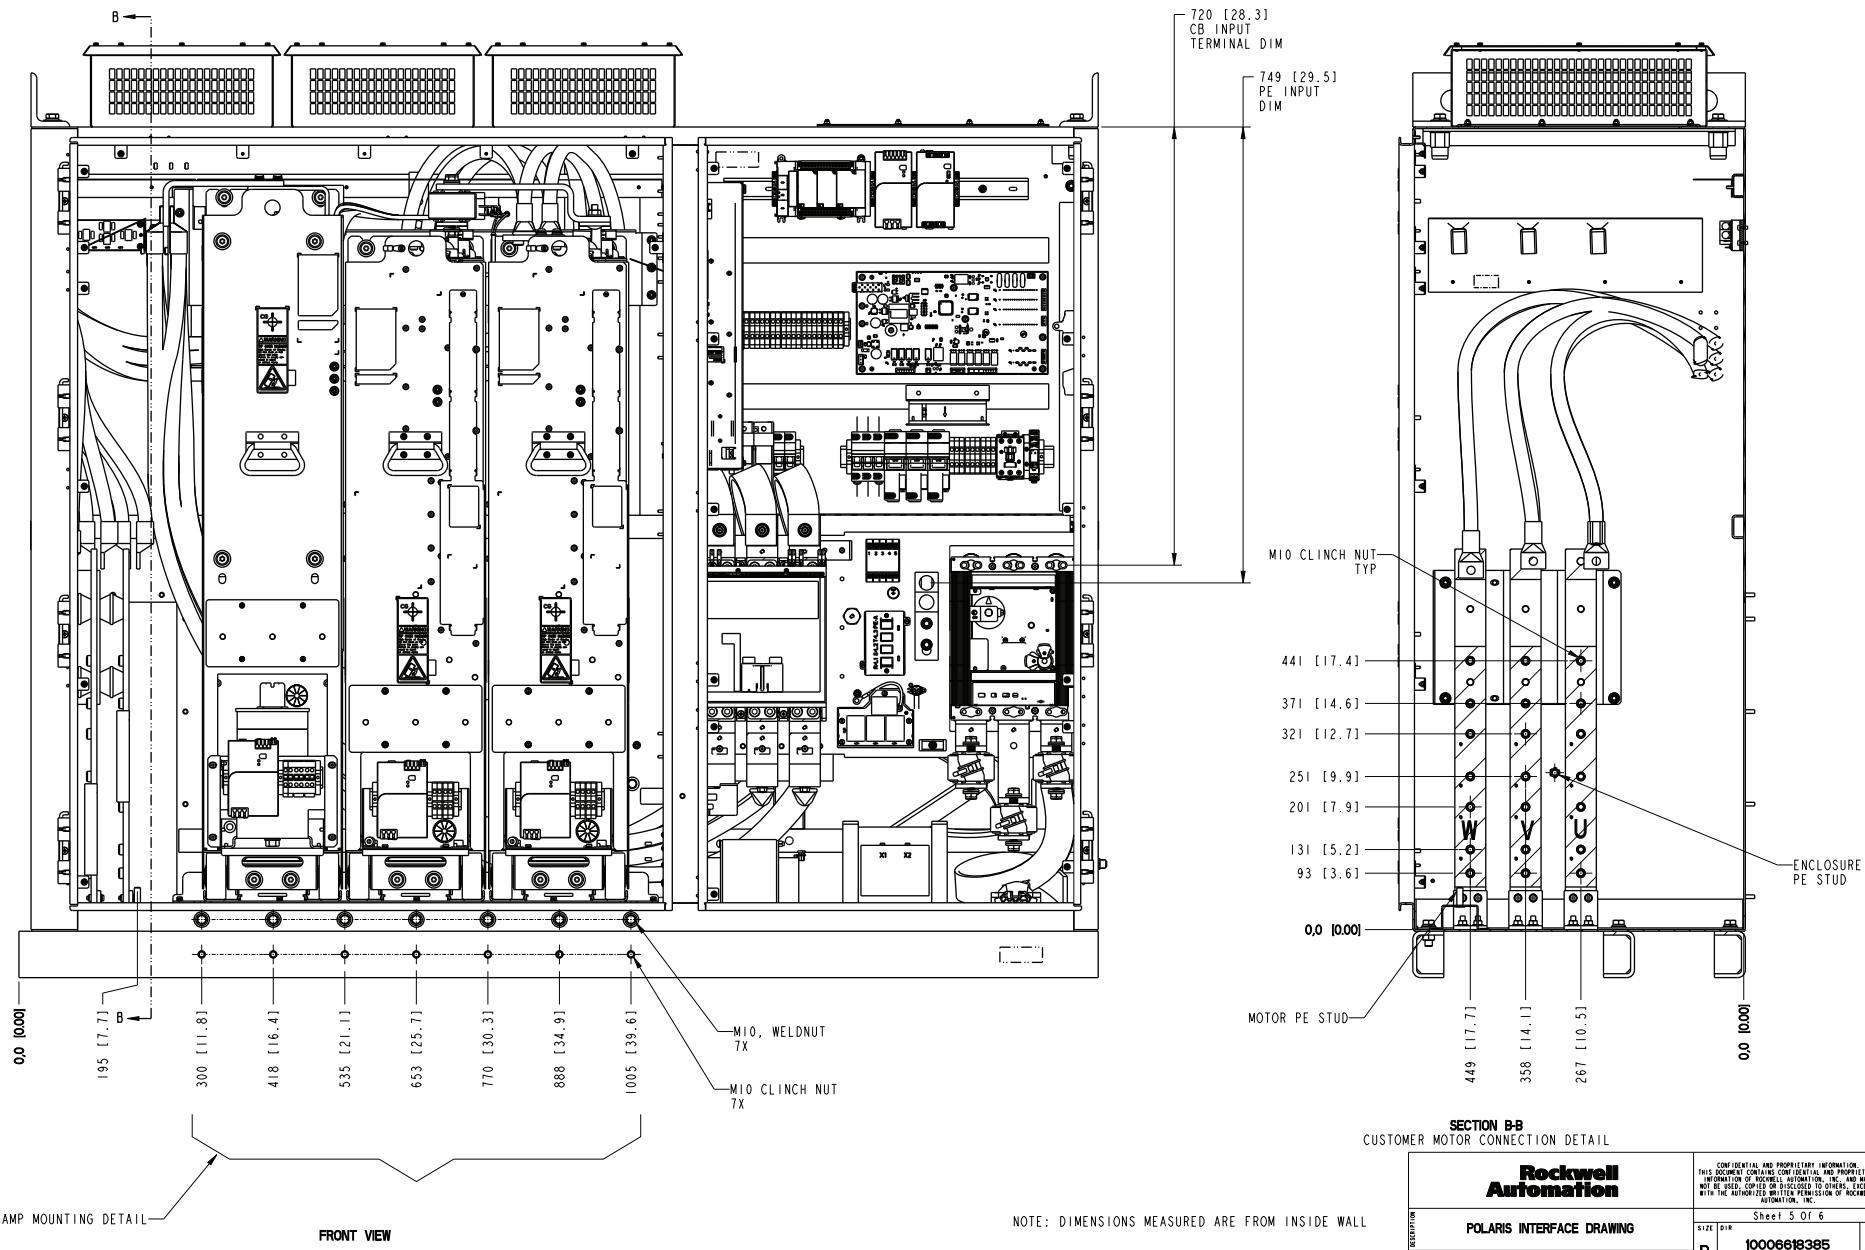
SECTION B-B
CUSTOMER MOTOR CONNECTION DETAIL

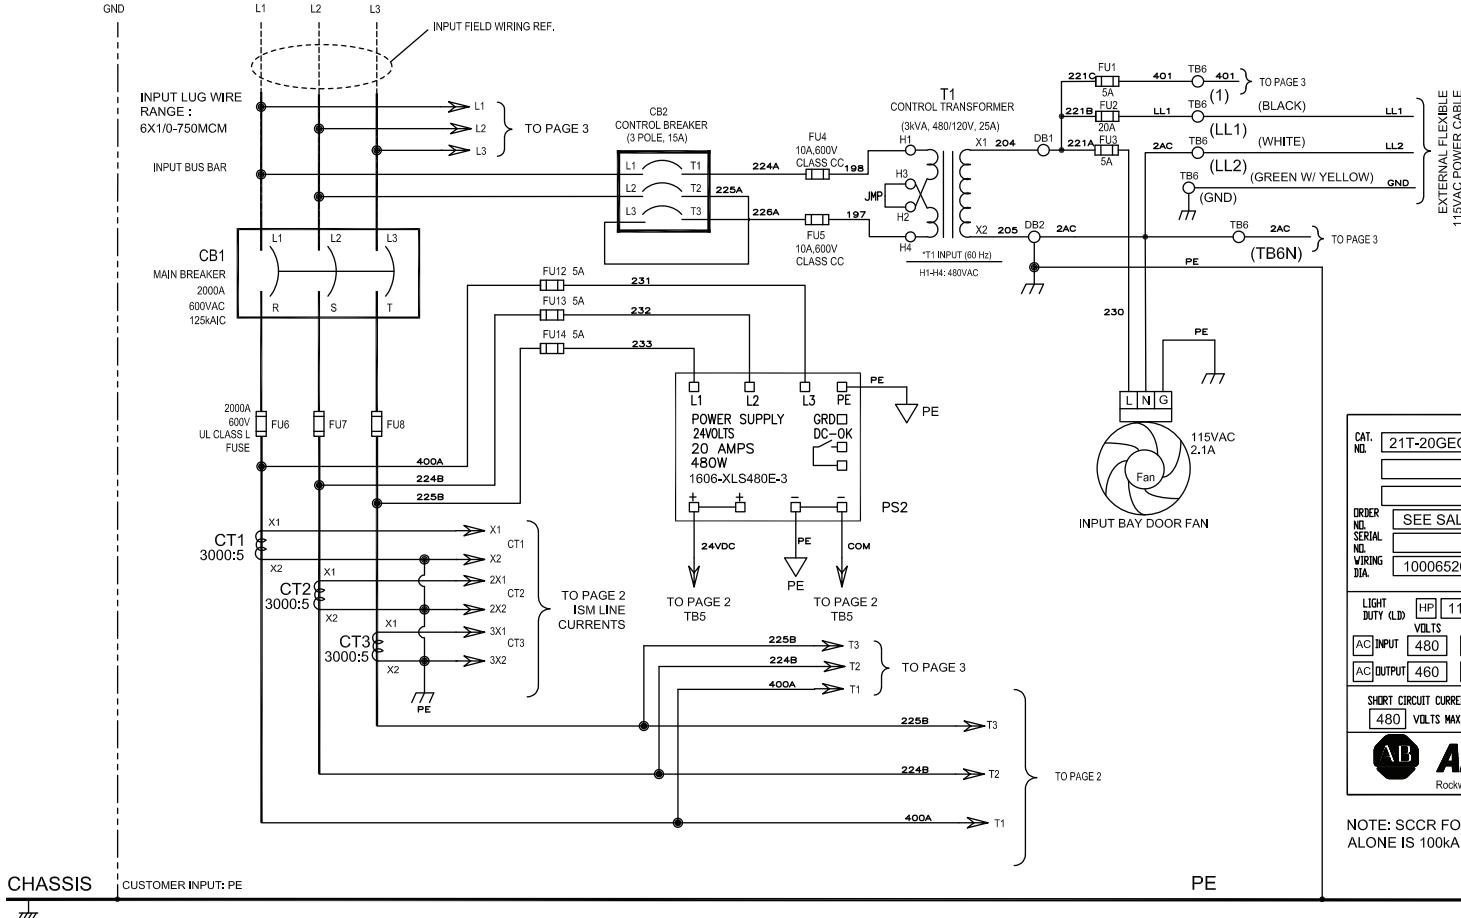
CARRIER XR6 PF755T 480VAC WIRING DIAGRAM

1.) DASHED LINES INDICATE EXTERNAL COMPONENTS AND WIRING BY OTHERS.

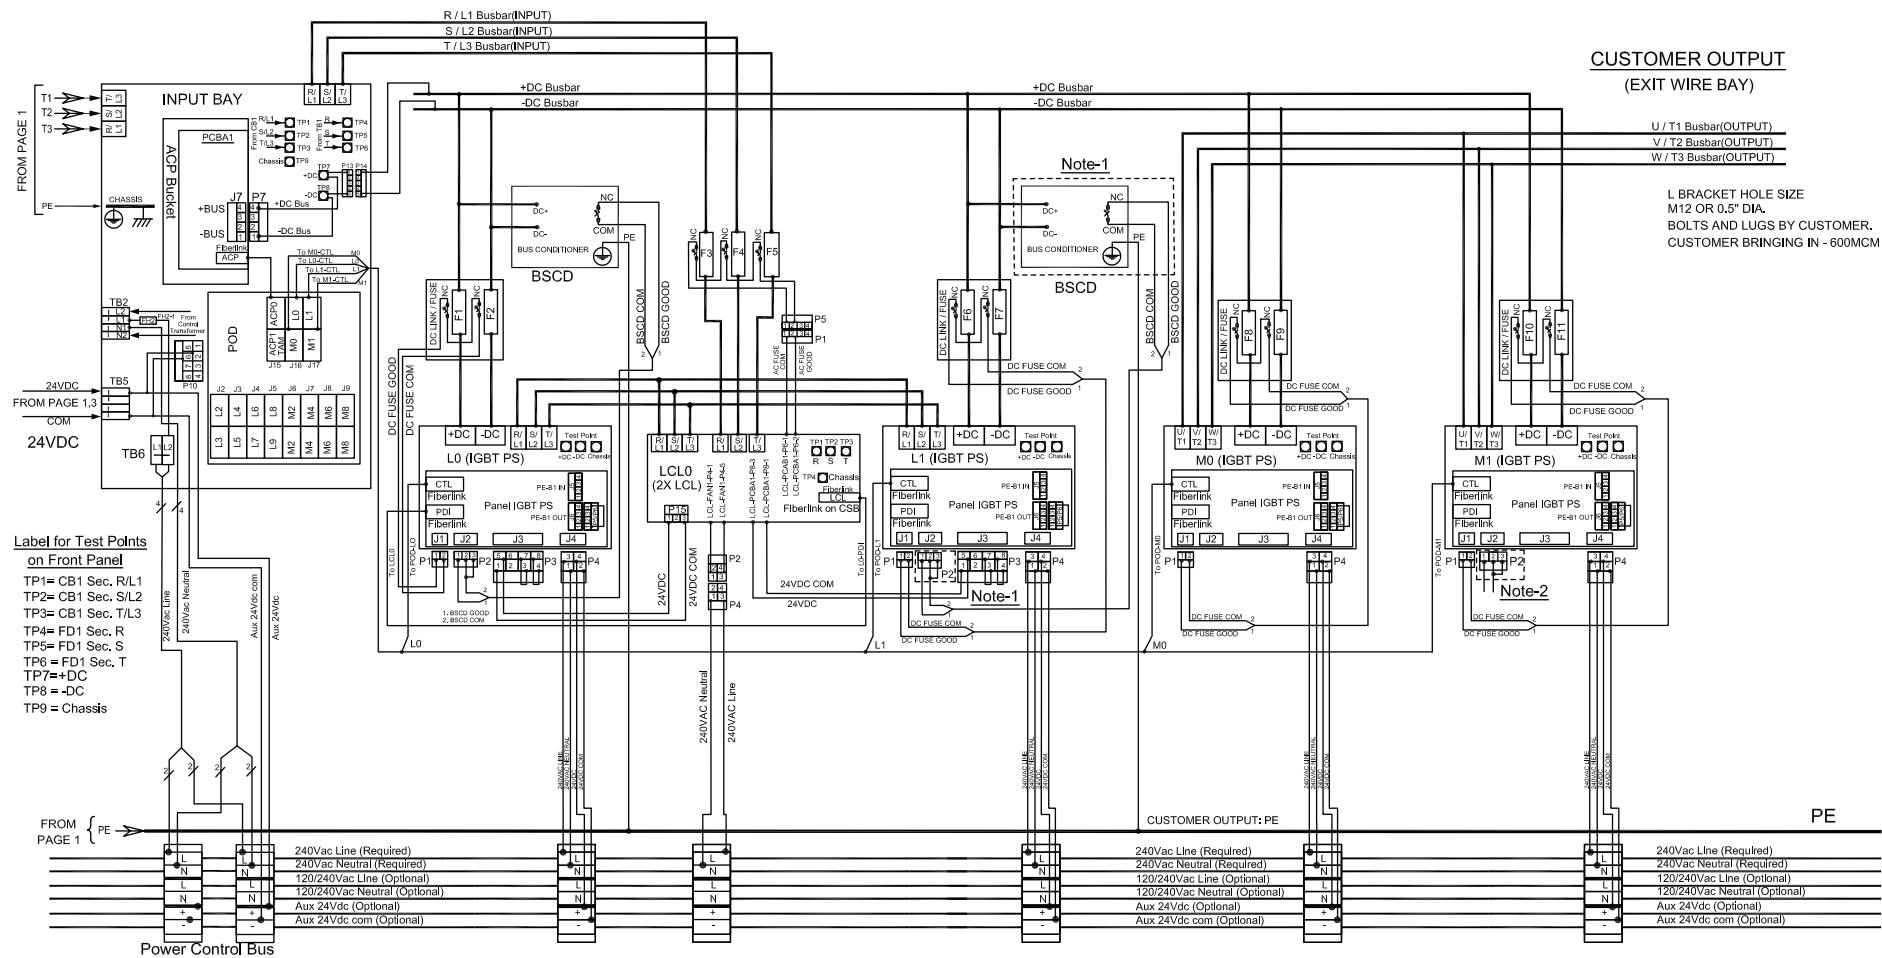
19XR Frame 9 PF755TL Example (cont)

Note-1: Applicable for HRG and Floating Ground System only (P50 Option).

Note-2: If Exit Wire Bay is present, connector P2 of Exit Wire Bay must be connected to J2 of IGBT-PS M1.
