AN EXCHANGE OF TECHNICAL INFORMATION

Number: TL001 - 2023
Subject: AL287 Real Time Clock Reset

Released: May 09, 2023

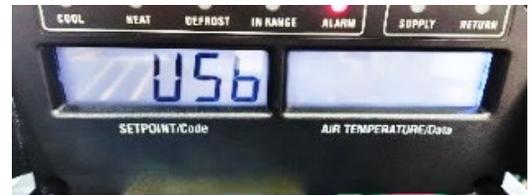
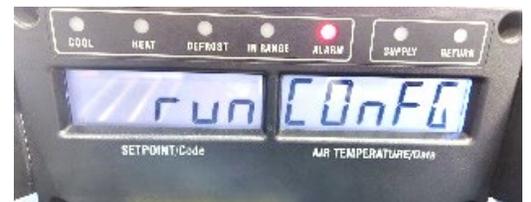
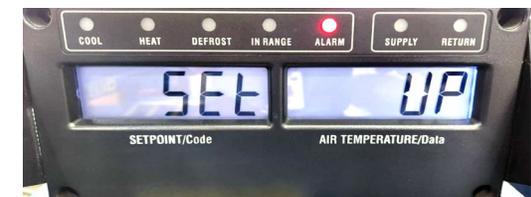
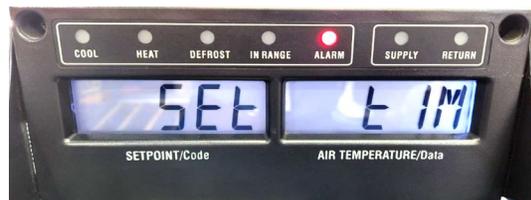
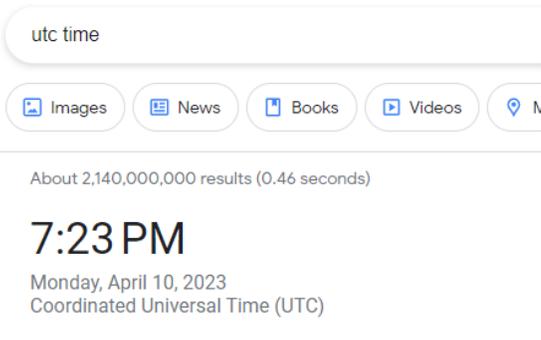
1. Power on the unit and connect a micro-B USB thumb drive.
2. After power up, press the ALT. MODE key and press the ENTER key upon seeing the USb option.
3. Use the Arrow keys to navigate to run COnFG and press ENTER.
4. Use the Arrow keys to navigate to SET UP and press ENTER.
5. Use the Arrow keys to select SET tIM and press ENTER.
6. Using your phone or computer, lookup UTC time.
7. The screen will show the year on the left screen and month-day on the right screen. The unit that can be changed will be flashing.

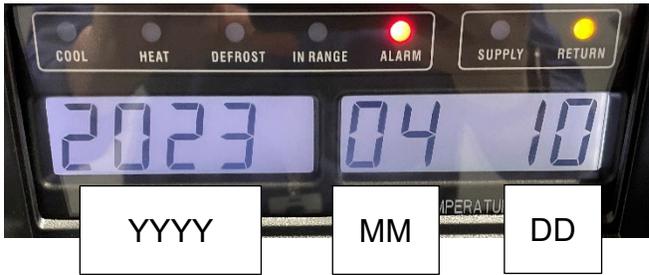
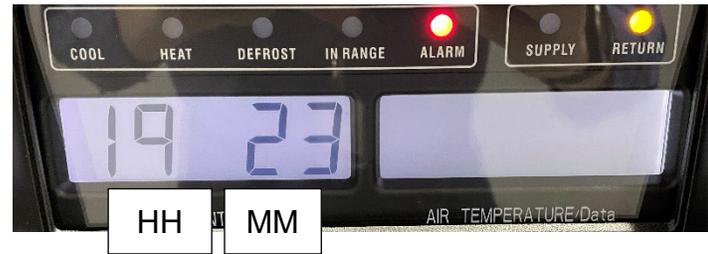
8. Use the Arrow keys to change the value and press ENTER to confirm. The screen will then show the hours and minutes in a 24 hour format. Use the Arrow keys to change the value to the CURRENT UTC time and press ENTER to confirm.

9. The clock has been successfully reset.
10. To check that the unit has updated, press the ALT. MODE key to the dC menu. Press ENTER and navigate to dC32 (Time: Hour, Minute), dC33 (Date: Month, Day), and dC34 (Date: Year).
